# A.T. Smith House Historic Structures Report

Prepared for Friends of Historic Forest Grove by

Historic Preservation Northwest

August 31, 2007

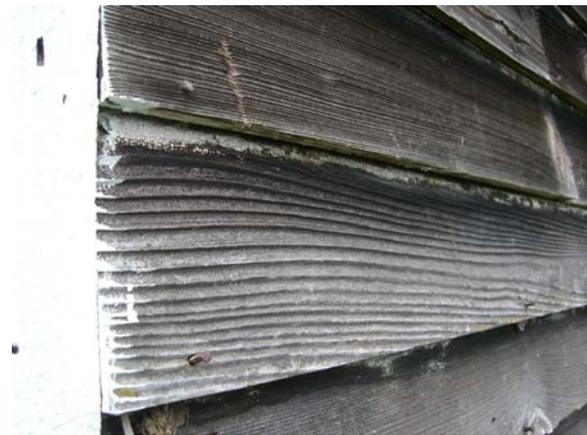
All walls are structurally stable and in good condition; however, the cladding on the rear (west) elevation is dry, cracked and missing nearly all its paint. There is a long, large crack in the siding between the two most northern windows on this side. Cladding around the other three elevations is in mostly good condition but has been replaced at the lower reaches (nearest the ground). Both wire and cut nails are visible in the original cladding pieces, which are all face nailed and mostly vertical grained.

For the cladding, the top priority is to repair/replace broken pieces and tighten up loose pieces. The west elevation should be addressed first. Tightening should be achieved with nails that have larger heads than finish so that they can hold the siding to the house as the wood swells and shrinks. It is not necessary to obtain cut nails, as there are already many wire nails visible. The wire nails also appropriately distinguish non-historic repairs. Epoxy, such as Abatron, is recommended for repairing cracks. Knot holes are not a concern where there is overlap from other siding boards, but otherwise they should be plugged and filled. Of course, the original builder of the house seemed to have a high degree of attention to detail, so if the stewards decide to interpret an early time period of the house, they should consider plugging and filling them all.

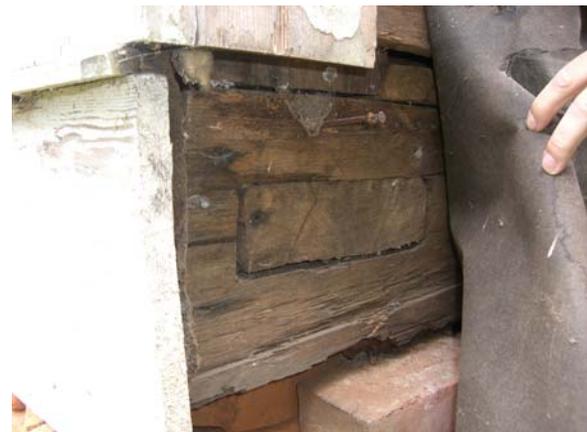
The water table (both board and cap) is missing from most of the south elevation, the only exception being the presence of the water table board below the aluminum window (no cap). Along this side, replacement lap siding continues down the walls to the brick foundation. The water table board is present along most of the east and west elevations, however, it is missing along the north elevation east of the door.

Water table boards and caps need to be replaced where missing (such as along the south elevation, under the west door and to the left of the north door) and reattached where loose so as to restore their role in shedding water from the foundation.

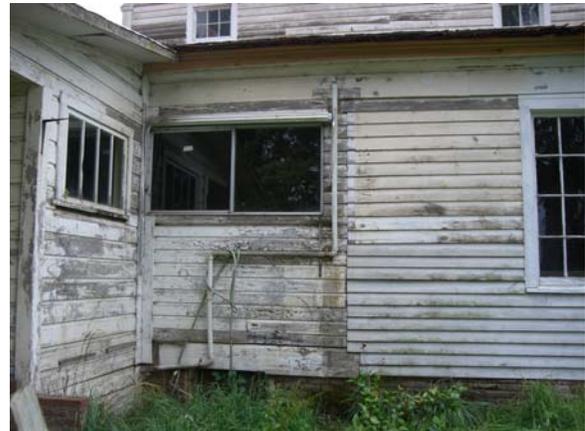
The vertical joint between the lap siding and the newer drop siding on the south elevation is problematic for water infiltration. The siding here should be fixed when the windows are restored, if not before. If the windows are to be left as is, the joint should be covered. A bead of exterior caulk with a backer rod would solve the water infiltration issue.

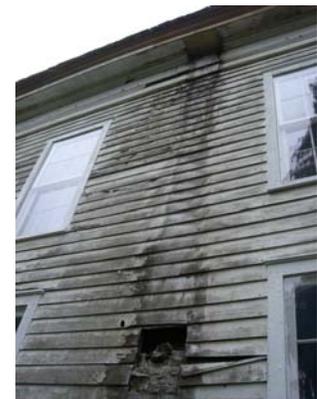
With regard to the decorative frieze, water table, and other such elements, they are in good condition with only a few exceptions. Along the west elevation, on the south end, the corner pilaster is missing its capital trim. The frieze is cracked along the south elevation and deteriorated along the north where the chimney was once present.

The deterioration of the frieze along the north elevation will require a Dutchman repair, or cutting back from the rotted sections to solid wood and filling the gap with a piece of the same dimensions. Before this is done, however, the nest inside the soffit here should be removed along with the visible moss. The cracked frieze along the south side may be repaired with epoxy instead of any actual replacement. Along the west elevation, on the south end, a missing pilaster capital should be rebuilt. The matching capital at the north end of this elevation

should be used as the model. All of these elements are important character-defining features of the exterior detailing but are not of immediate concern.

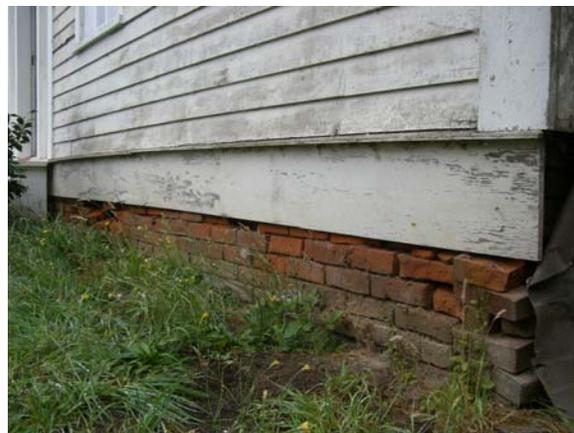
There are two holes or depressions along the perimeter. One, along the north elevation at the basement window, looks to be a site drainage issue. The other, along the south elevation, is located below the wooden patch covering the foundation. It appears to be a hole dug by an animal, and it is certainly large enough for a cat or raccoon to enter. Given the uninhabited state and relative isolation of the house, this could be a concern for the short term.

The opening at the basement window along the north elevation should be filled in before the start of the next rainy season. With regard to the south elevation hole, it should be filled in to discourage entry for small animals which could wreak their own havoc.

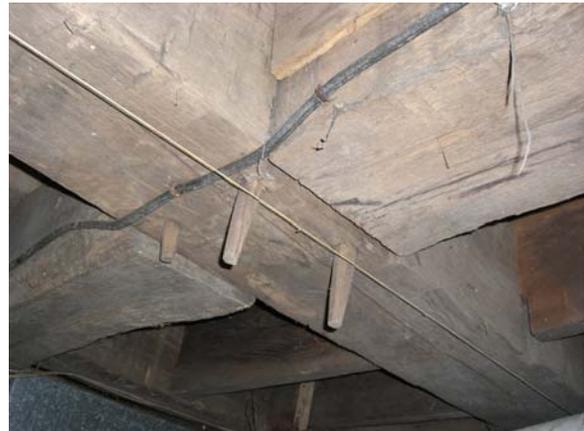
There are 11 posts helping to support the east-west beams in the center of the basement. Some of the posts are old, but most are temporary, inserted to try to support the sagging floor. None of the posts appear to date to the construction of the basement. This is probably due to moisture rot of the posts and a continually sinking floor. However, there may have been the belief that the large-dimension beams could span the space without posts. There are three posts along the south wall supporting a temporary beam that is picking up failing south beam/joist connections. At the center of the north wall is the floor structure for the original fireplace, now removed. In the northwest area of the foundation, there is bridging between the joists, the only area to have bridging. The bridging is quite crude, not at all matching the skill of the frame; however, the diagonals do appear to have been installed before the floor was laid down (the bridging is nailed from the top) indicating that the bridging is original to the house.

Proper posts should be inserted at the four intersections of the beams. These should be large, at least 6"x6", if not physically required, at least visually required. Douglas fir would be the best material and would be somewhat obviously not original to the structure. The footing pads for the posts should be large, perhaps 3'Lx3'Wx6"H, to spread the load and prevent sinking. A small raised portion of concrete, about 6"Lx6"Wx2"H, should be centered on the concrete pad to create a plinth for the post. The pad should be installed at grade so that the floor grade will hide the concrete and expose just the plinth. The post should then sandwich a composition shingle between it and the concrete to prevent wicking up the post.

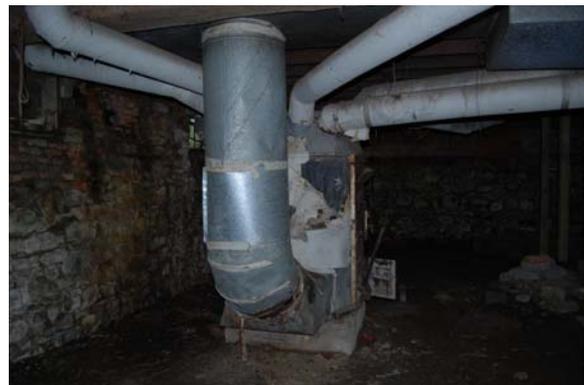
The basement is dominated by a furnace from the late 1920s. It is a “Torrid Zone” TZ6 50-22 made by Lennox Furnace Company of Marshalltown, Iowa, and Syracuse, New York, according to its firebox door. Lennox didn’t start the Syracuse factory until 1925, so the basement furnace most likely dates to the late 1920s. The massive, octopus-style furnace has eight ducts. Two ducts head west, two head east, and two head towards the southeast. The remaining two are cold air returns, one is directly over the furnace and the other comes from the northeast corner.

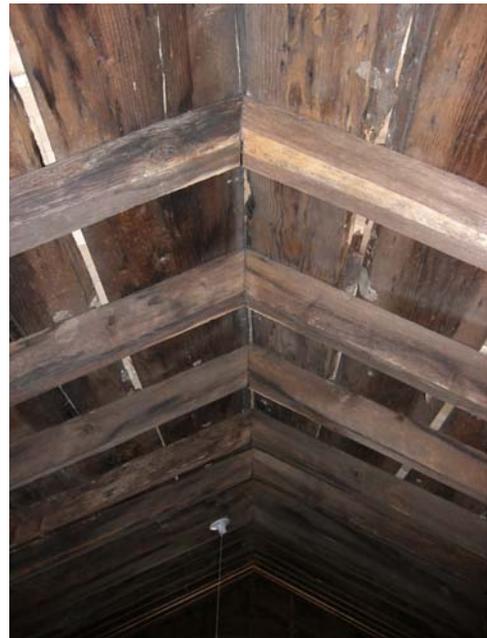
In the former chimney area, a new rafter has been sistered on to a discontinuous rafter (image 929). The northern section of the historic rafter appears to be sawn through while the southern end is more deteriorated. As this is in the area of former water infiltration, this rafter was damaged and the rotten section removed in 2007. Stability has been restored with the new member but full replacement would be a visual improvement.

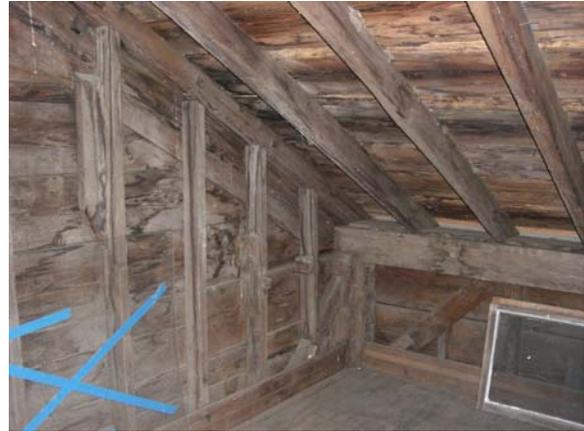
Wire mesh covers openings in two places, in the soffit by the former chimney area and under the east end of roof ridge at the soffit area (see images 932 and 914/915). Bird nests are visible through the mesh at both, but it is not evident if the nests are current or remnants of previous inhabitants. The only other visibly potential gap is at the end of the western ridge.
