# Frantz-Dunn House

## Condition Assessment Report 1997

By: David Pinyerd, Historic Preservationist

For: Benton County Parks

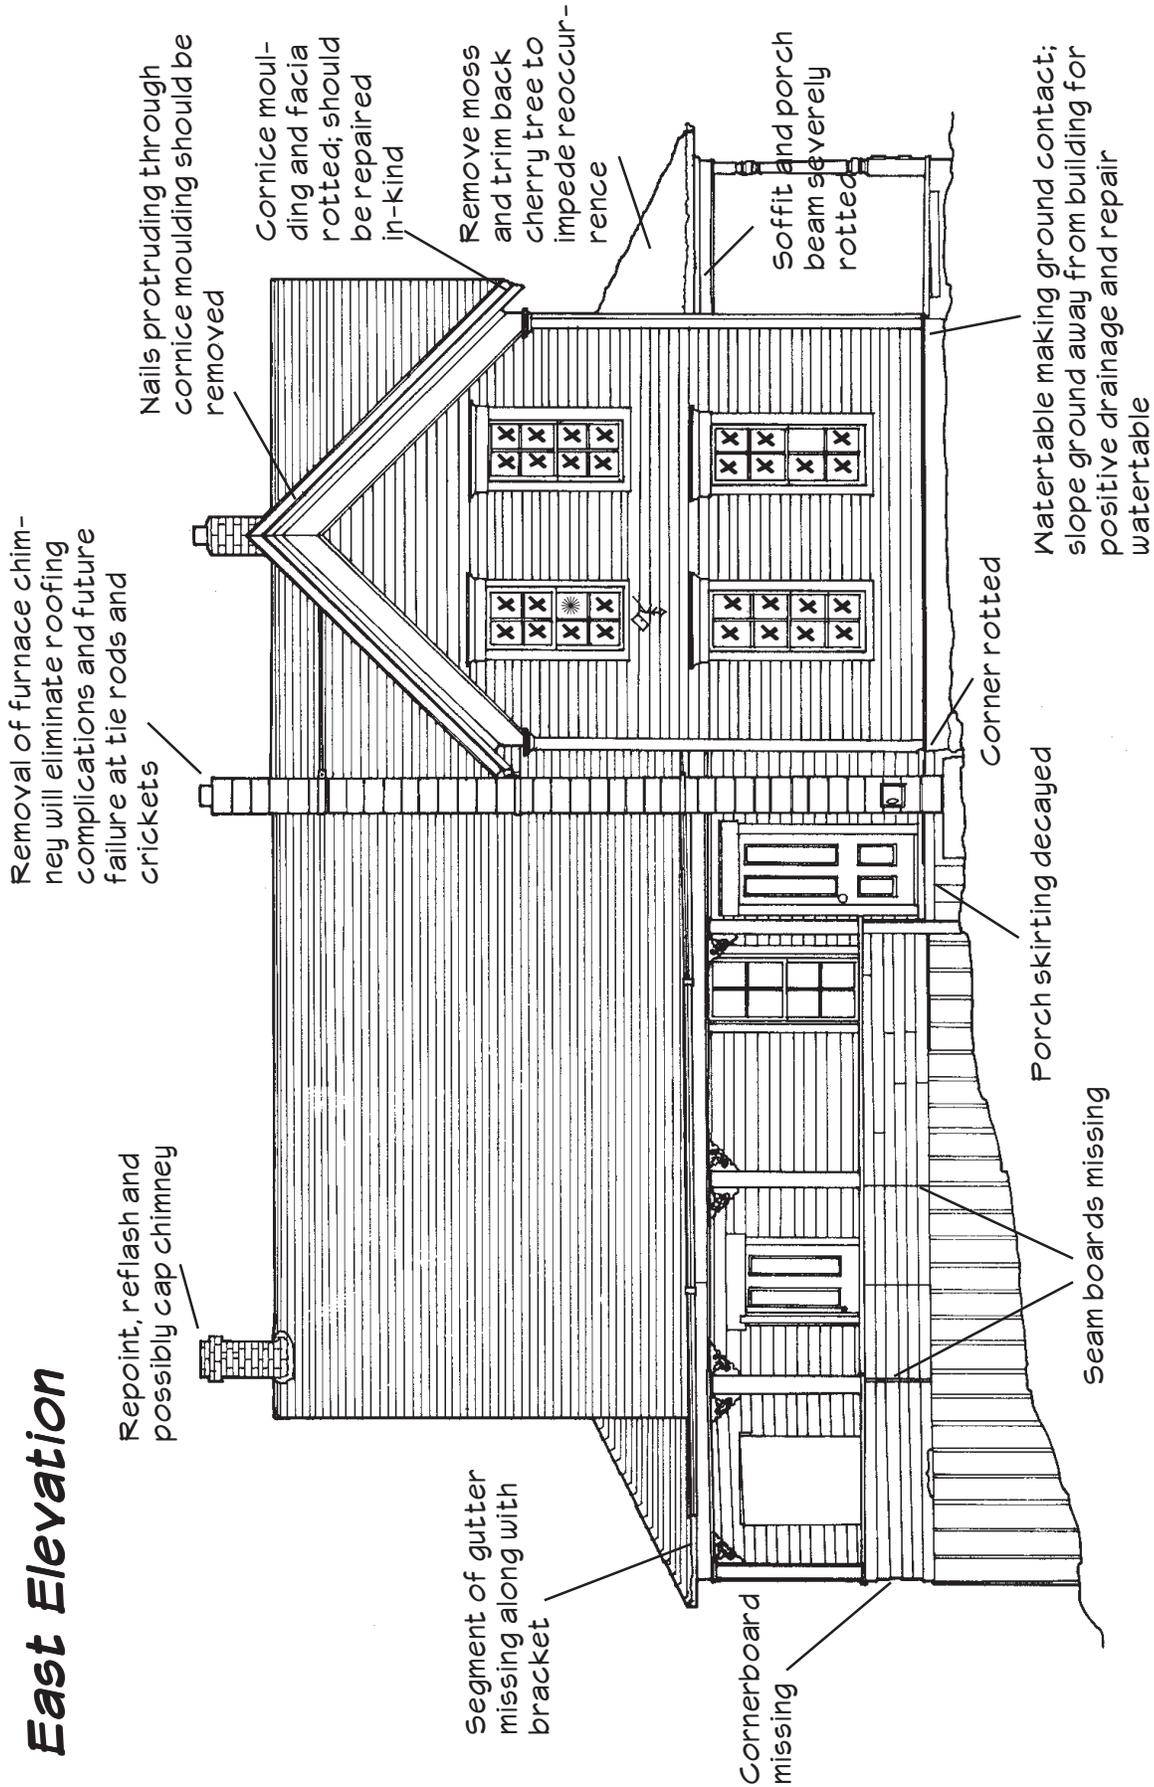
# East Elevation

x - Needs reglazing  
 \* - Needs replacement

The windows exposed to weather (not those covered by porches) are in desperate need of reglazing. I have marked with an "X" on the elevation drawings those window panes that need reglazing. I have marked with an "✱" those panes that need replacing due to significant cracking or holes.

**Solution:** All window sashes exposed to the elements should be removed one at a time to a convenient work area, the glass carefully removed, the wood stripped with a putty knife and heat gun, the wood double primed, the glass reinstalled with appropriate glazing points, the glazing putty (e.g., DAP glazing compound with linseed oil) applied carefully, and the window painted.

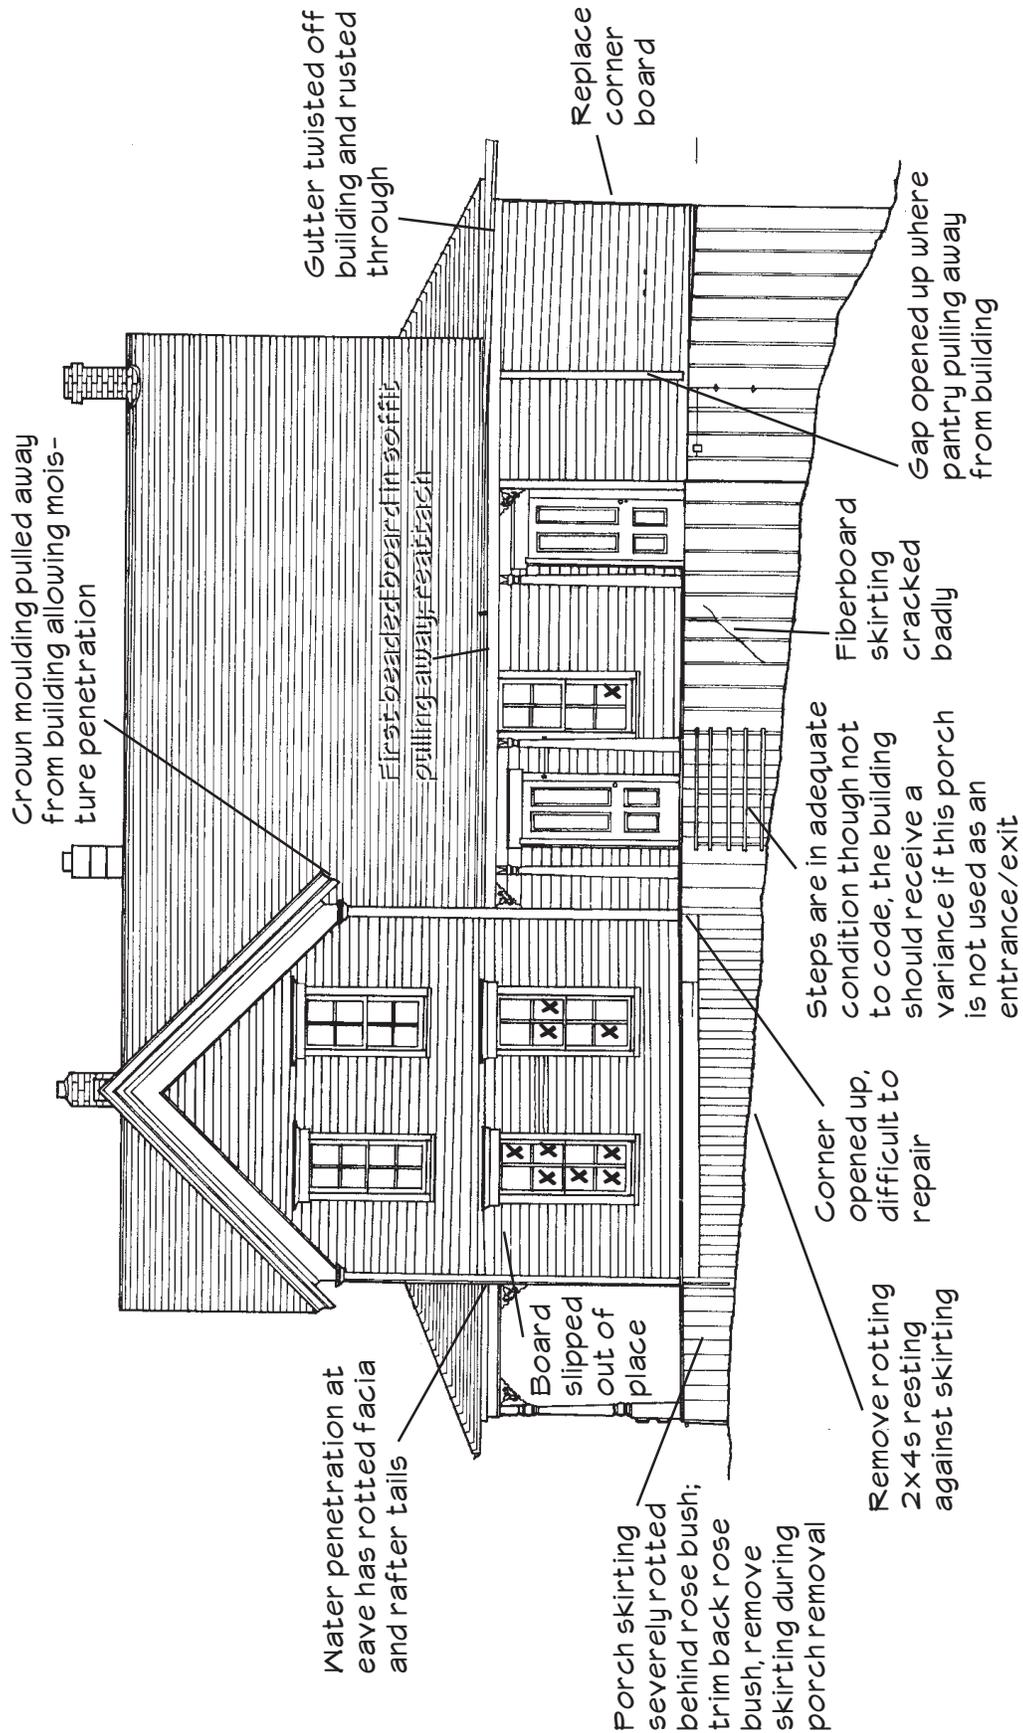
# West Elevation

x - Needs reglazing  
 \* - Needs replacement

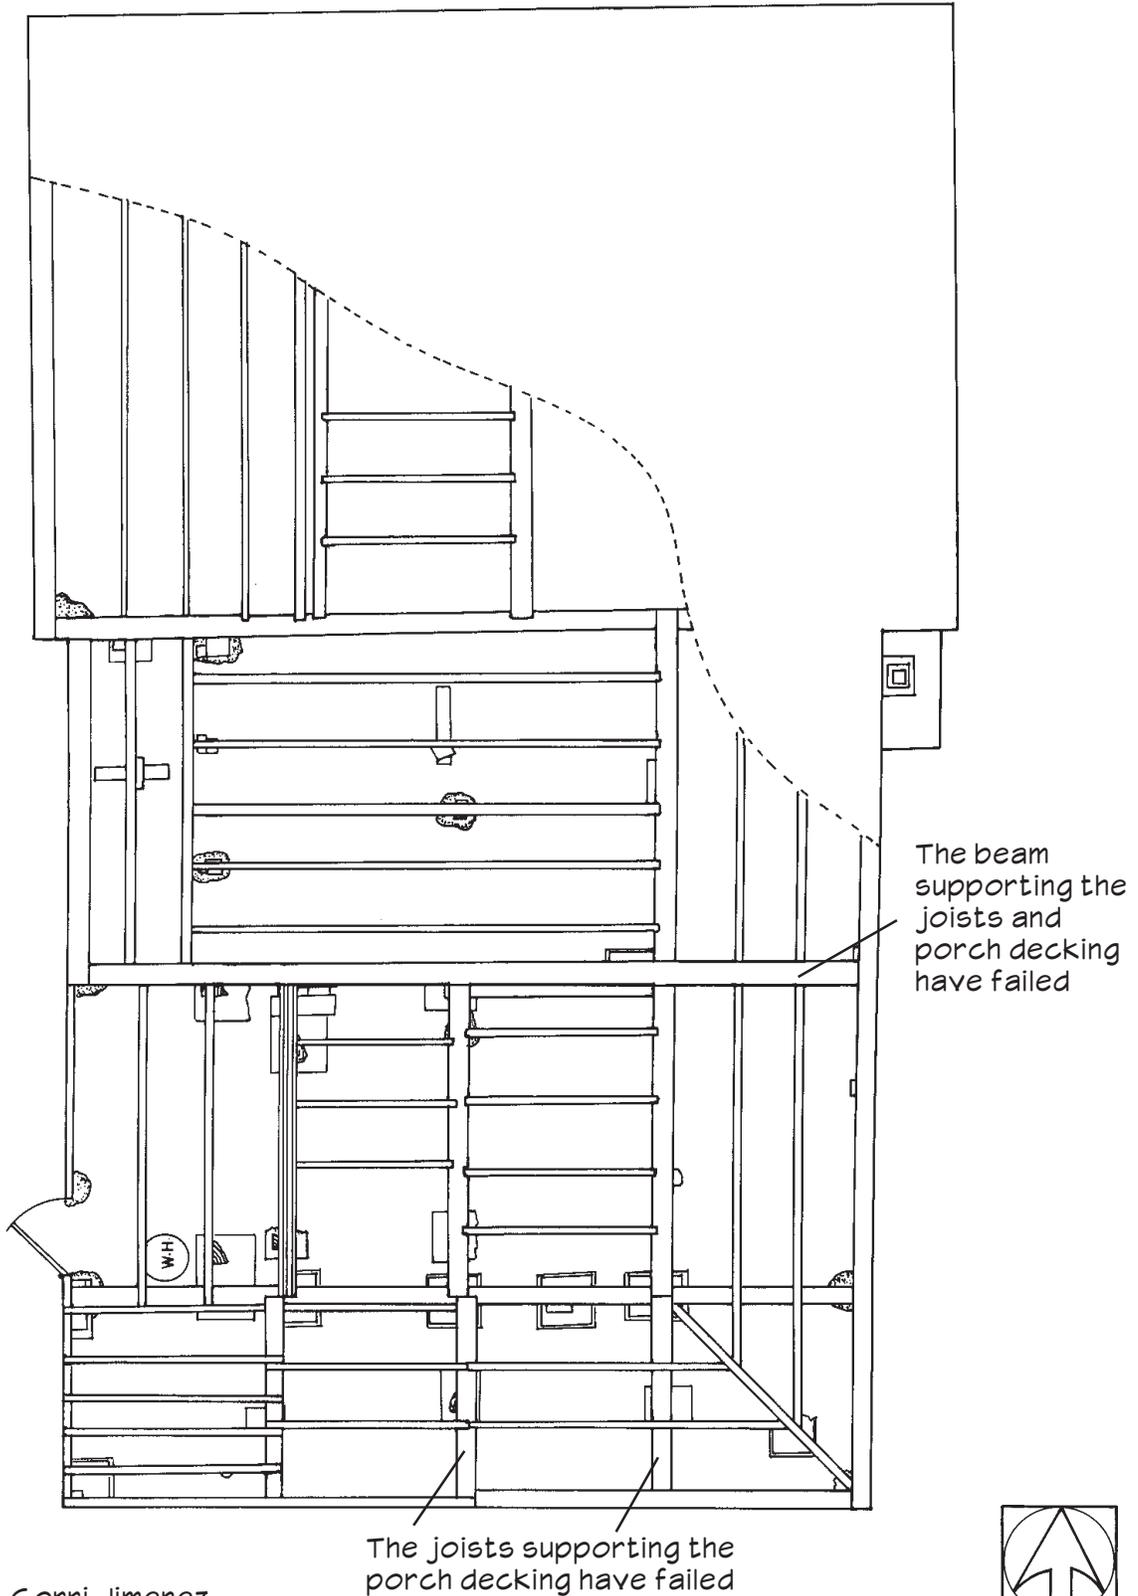
# Foundation Plan

The foundation system is in fair condition. The posts and beams under the body of the house are in good condition. The size of the members and the support they are providing is quite adequate. However, in the case of an earthquake, since none of the posts are anchored to either their piers or the beams, this building is going to fall off of its support structure.

Where the foundation is really a mess is around the perimeter underneath the porches. Water and insect damage have taken their toll on the members. There is a purposeful slope to the porches so that the decking can shed water away from the building. However, water has collected over the years at the half wall surrounding the east and south porches, filtered through the tongue and groove decking, and provided an ideal situation for insects and rot. There is white rot on the underside of the decking on the south porch and insect damage to the rim joist, decking, and connecting beams.

There is some settling in the corners (the NW corner has settled six inches), but this is attributable to sinking posts and pads and does not indicate failure of the wall, beams, or joists. There is also a gap of three inches between the west pantry wall and the pantry.

**Solution:** The decking of the east and south porches must be replaced. The rim joist that carries the half wall will have to be re-

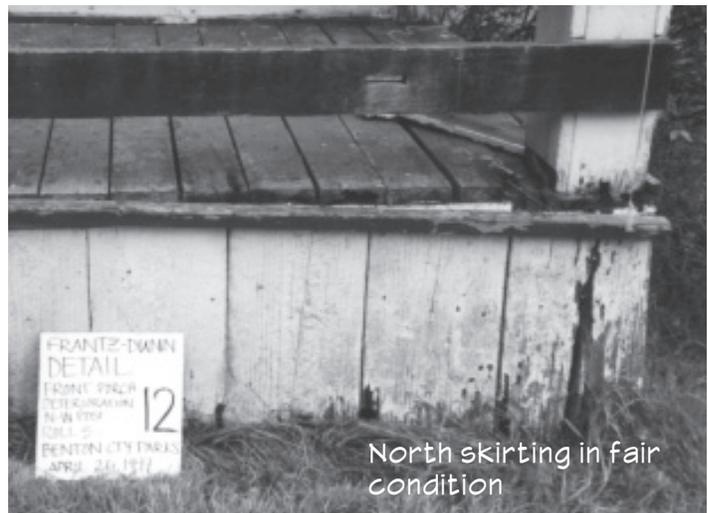
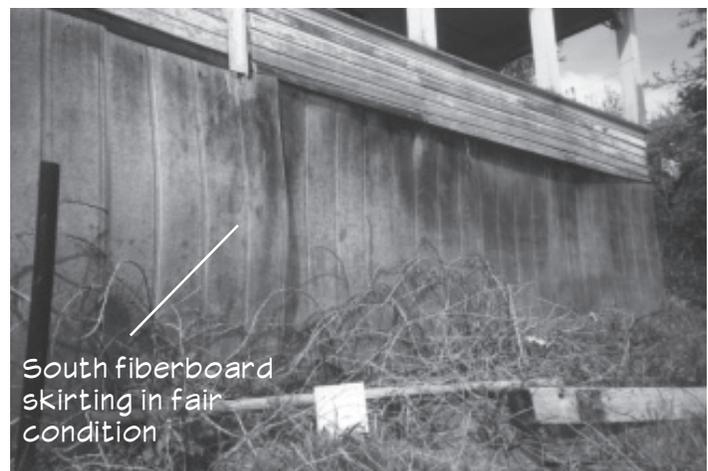
The skirting is rotting around the north half of the house. The south half of the house has a fiberboard skirting material that is warped, buckled, cracked, and inappropriate.

**Solution:** The skirting is doing little at this point other than keeping out very large animals. However, it is doing little harm to the house. Therefore, until the perimeter foundation idea comes to fruition, the skirting should be retained. The grass should be continued to be trimmed from around the house to prevent accelerated rotting of the skirting.

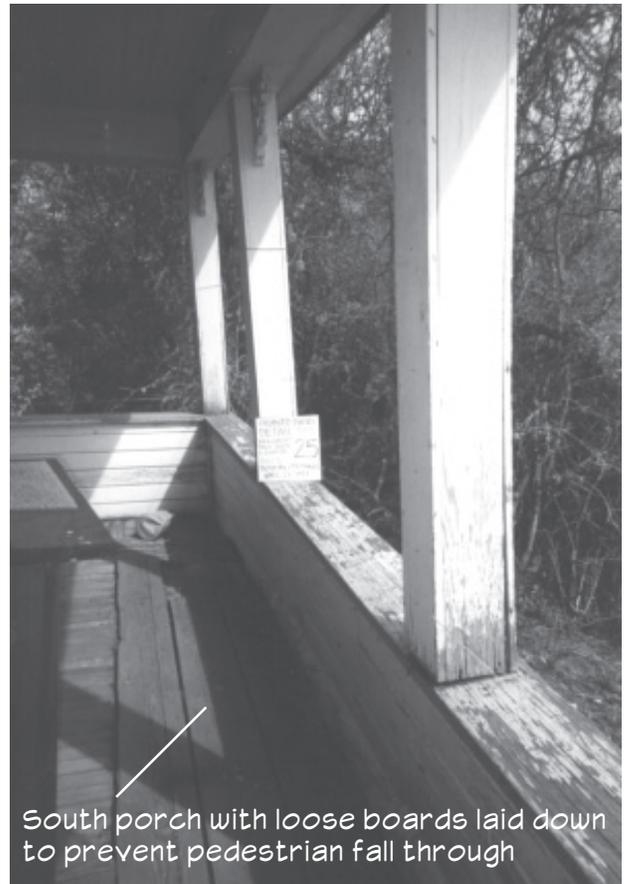
As mentioned in the foundation section, the tongue and groove decking on the south and east porches has failed. The ends have rotted out from half wall and rim joist and are no longer supported. Currently, plywood, loose boards, and the tongue and groove decking's rigidity are all that is keeping a visitor from falling through.

South porch with loose boards laid down to prevent pedestrian fall through

**Solution:** As described in the foundation section, the tongue and groove decking should be replaced on the south and east porches. The decking should be retained on the north porch until the entire porch is removed in 1998. The 2"x6" decking on the west porch should be retained until it can be replaced with an appropriate tongue and groove decking.

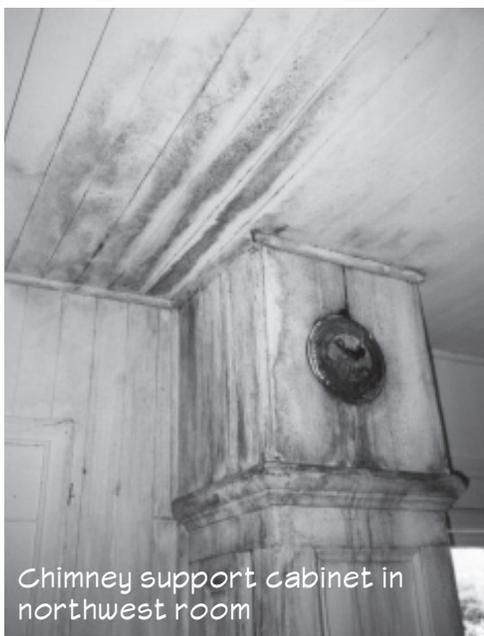
Chimney support cabinet in northwest room

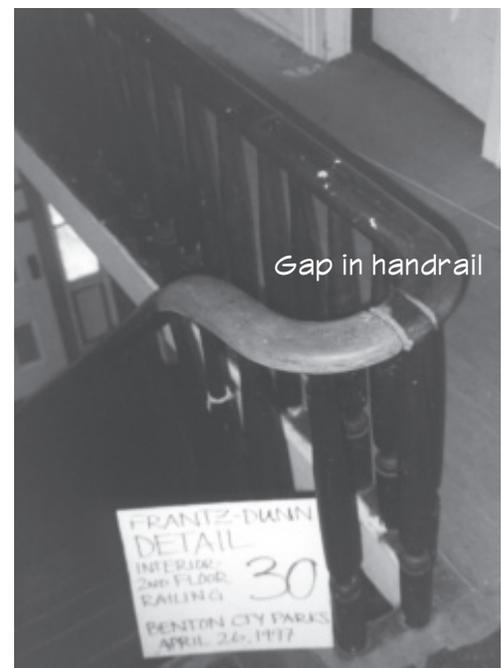
Gap in handrail

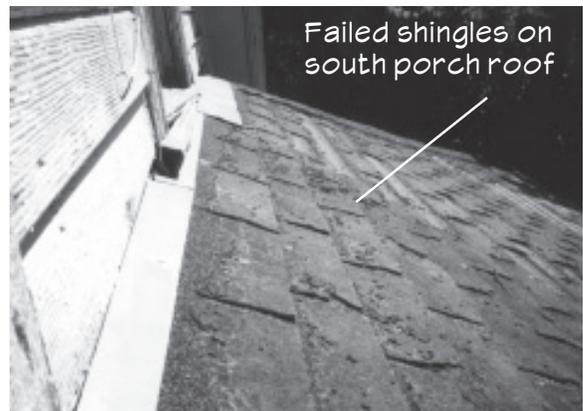
The current asphalt shingles are extremely worn on the south porch and in poor condition on most of the house. The shingles on the west elevation have perhaps five years of useful life. Benton County Parks has already slated the house for a new roof in early August 1997. The ideal replacement for the asphalt shingles would be a return to the cedar shingle roof. However, the cost of cedar shingles has become exorbitant and the idea has been rejected. The next best alternative would be a composition shingle product that simulates cedar shingles. Unfortunately, this concept is ahead of the market and there is currently no product that simulates cedar shingles. There are several products that can be used to simulate the thick and uneven qualities of cedar shakes, but none available to simulate the smooth surface and regularity of cedar shingles.

**Solution:** I have examined many of the asphalt roofing products available from manufacturers, surveyed the product in the field, and have not been satisfied with anything I've seen. The newer laminated shingles (e.g., Owens-Corning's Oakridge Shadow) come close to simulating the depth of a shingle but have none of the characteristic evenness nor the simple blend of gray and black that make up a cedar shingle roof that is several years old. The laminated shingles cost around \$60 a square and have a 40-year warranted life. A step down from the laminates are the pseudo-laminates (e.g., Owens-Corning's Prominence) that use color in the grains to simulate depth. Owens-Corning has a "desert tan" in the 30-year Prominence line that is quite similar in appearance to a new cedar shingle roof before it has silvered out. The

closest I could find to simulating an aged cedar shingle roof is "coastal gray" in the Prominence line. It would provide a lighter color and some texture for the roof which I believe is an important step towards recreating what was once on the roof. RoofLine in Coburg (ph. 541-345-1253) is currently selling this three-tab shingle at \$34 per square, delivered to the roof. I must emphasize that this not an adequate substitute for a cedar shingle roof in color or texture, but is a compromise that I believe is a step above a three-tab black composition shingle roof.

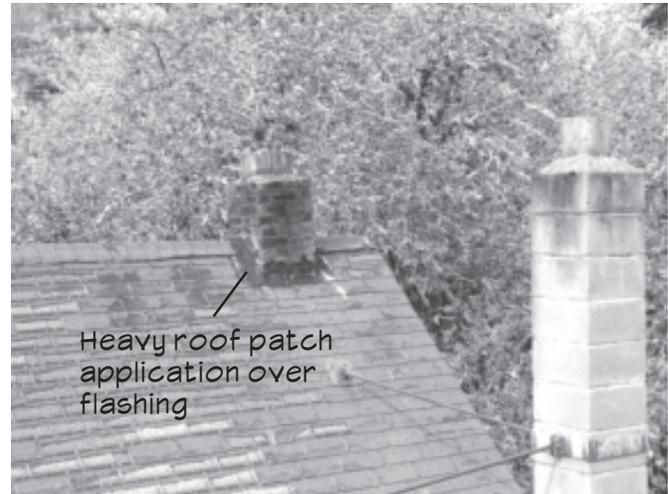
The flashing at the chimneys has failed. Valley flashing shows surface rust but is still sound. There are no roof vents.

**Solution:** A new roof is only as good as its flashing, and this roof is in desperate need of a proper flashing. Benton County Parks has already decided to tear off the old composition roof before installing a new one. After tear off, all roof flashing should be replaced. Valleys will need

new stainless steel flashing. Roof edges should also be flashed, being careful to reveal a minimal amount along the crown moulding, perhaps 1/2", and not the standard 2" reveal. The chimney flashing shows many years of attempts to keep water out through roofing tar applications, heavily applied. A proper flashing job where the step flashing is let into the brick joints and then mortared in should solve the leakage problem.

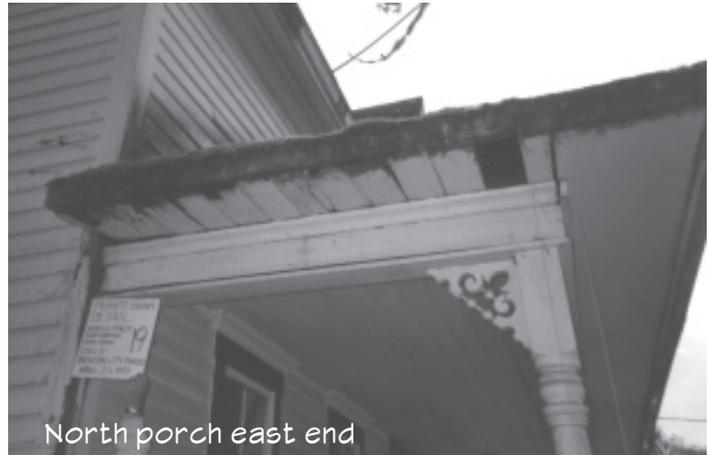
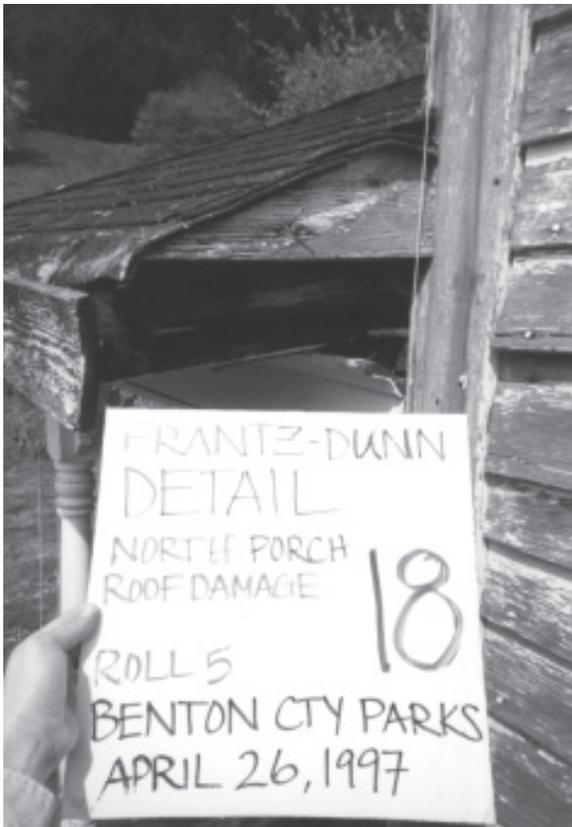
The plywood sheathing is in excellent condition and being well protected by the asphalt shingles in most areas. The only point in which the plywood is in poor condition is at the east and west ends of the north porch. At the east end, moss buildup on the roof has trapped huge amounts of water and held it against the fascia board. The fascia board has rotted away

and the rafter tails along this edge have gone with it. The plywood, too, has been consumed in this area to the point that this area cannot be walked upon. On the west end, water has gotten behind the fascia board, rotting it out along with the rafter tails.

**Solution:** During tear-off, all sheathing should be inspected. This would be an opportune time to remove the galvanized nails someone had carelessly shot through the edge of the plywood sheathing, through the edge of the crown moulding, and left the ends of the nails dangling, exposed like a line of Christmas lights at the eave. Any failed plywood should be replaced and the source of the failure evaluated. Since the north porch is not going to be removed until the summer of 1998, the porch roof should be resheathed in plywood at both the east and west ends.

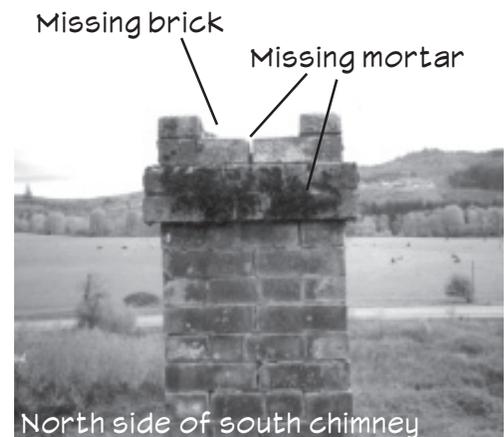
The chimneys are the cause of half of the damage that this house is receiving. They are the main entry points for water on this roof.

The only chimney to be capped, the NW chimney, shows no water damage in the interior below. Some rusting around nails is evident; however, it is caused most likely by condensation and not running water. Capping would also prevent insect infestation, such is occurring on the south chimney. The south chimney also has a vertical crack running through several bricks.

**Solution:** After removal of the wasps in the south chimney and repointing of the NE and south chimneys in-kind, I recommend capping both the south and NE chimneys. This would prevent water penetration and insect infestation. The cause of the brick cracking in the south chimney should be found. The

length of chimney in the attic area above the south bedroom will probably reveal the cause. I imagine settlement and water penetration are the most likely causes of the cracking. Replace the broken bricks during repointing.

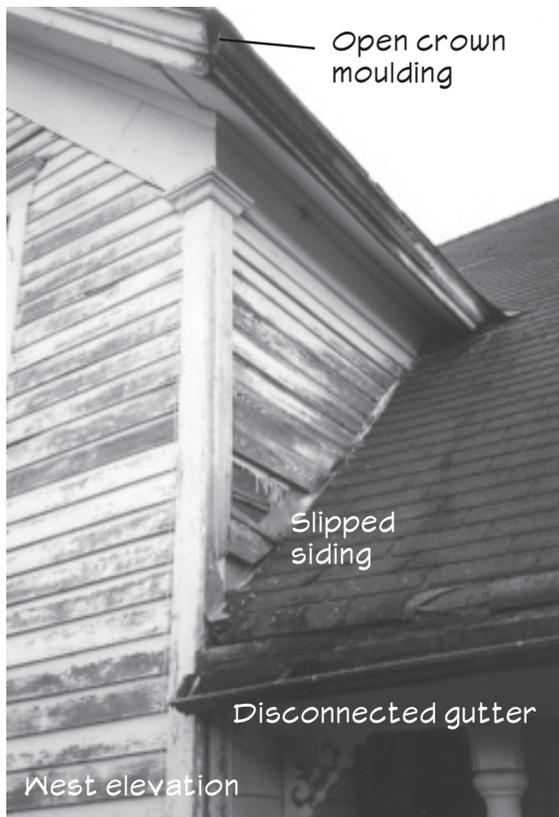
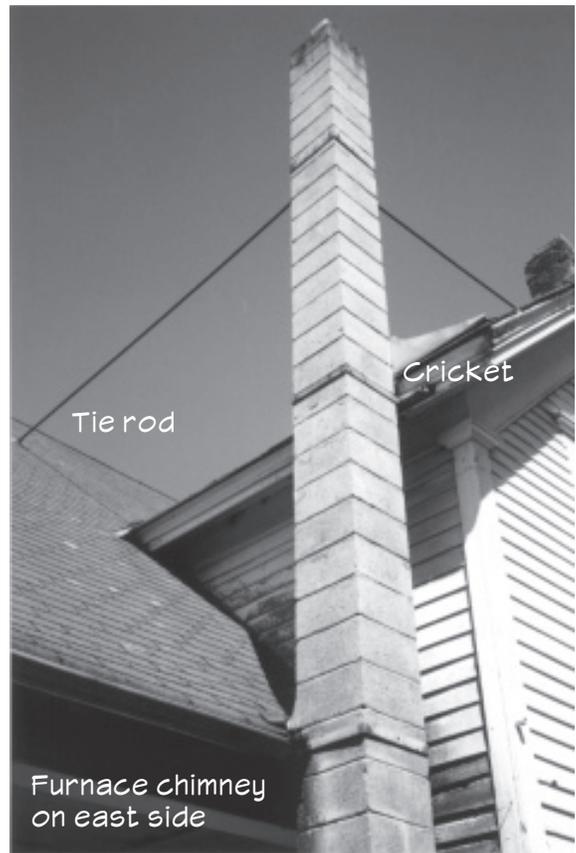
west porch, and one on the east porch. The north porch gutter is performing well. The west porch gutter has pulled away from the building and is rusted through. The east porch gutter has lost its southern segment and has pulled away from the building.

**Solution:** There will be a temptation to put gutters on all the eaves of the house. At most, I would recommend the replacement of only the existing gutters; my preference would be the removal of all gutters from the building. Gutters do not appear in the historic photographs and I believe their detrimental effects outweigh their benefits. The failure of the gutters at east and west porches has caused water to wick up into the eaves, resulting in rot in the facias and in the soffit on the west porch. If the gutter was absent from the east and west sides, water would run off the overhanging edge of the asphalt

shingles and fall to the ground. There is positive drainage away from the house on the east and west sides and any splash would be minimal. This is evident on the south end of the building where there is no gutter and the fascia is in perfect condition.
