Project Description

The proposed project is to evaluate the buildings of the Lowell Ranger Station as to their potential listing on the National Register individually or as a district. Individual inventory forms for ten buildings are attached. Figures 1 through 3 show the location of the Lowell Ranger Station. Figures 4 and 5 are historic views of the compound. Historic photos of the individual buildings are included with their respective inventory forms.

**OREGON INVENTORY OF HISTORIC PROPERTIES
SECTION 106 DOCUMENTATION FORM**

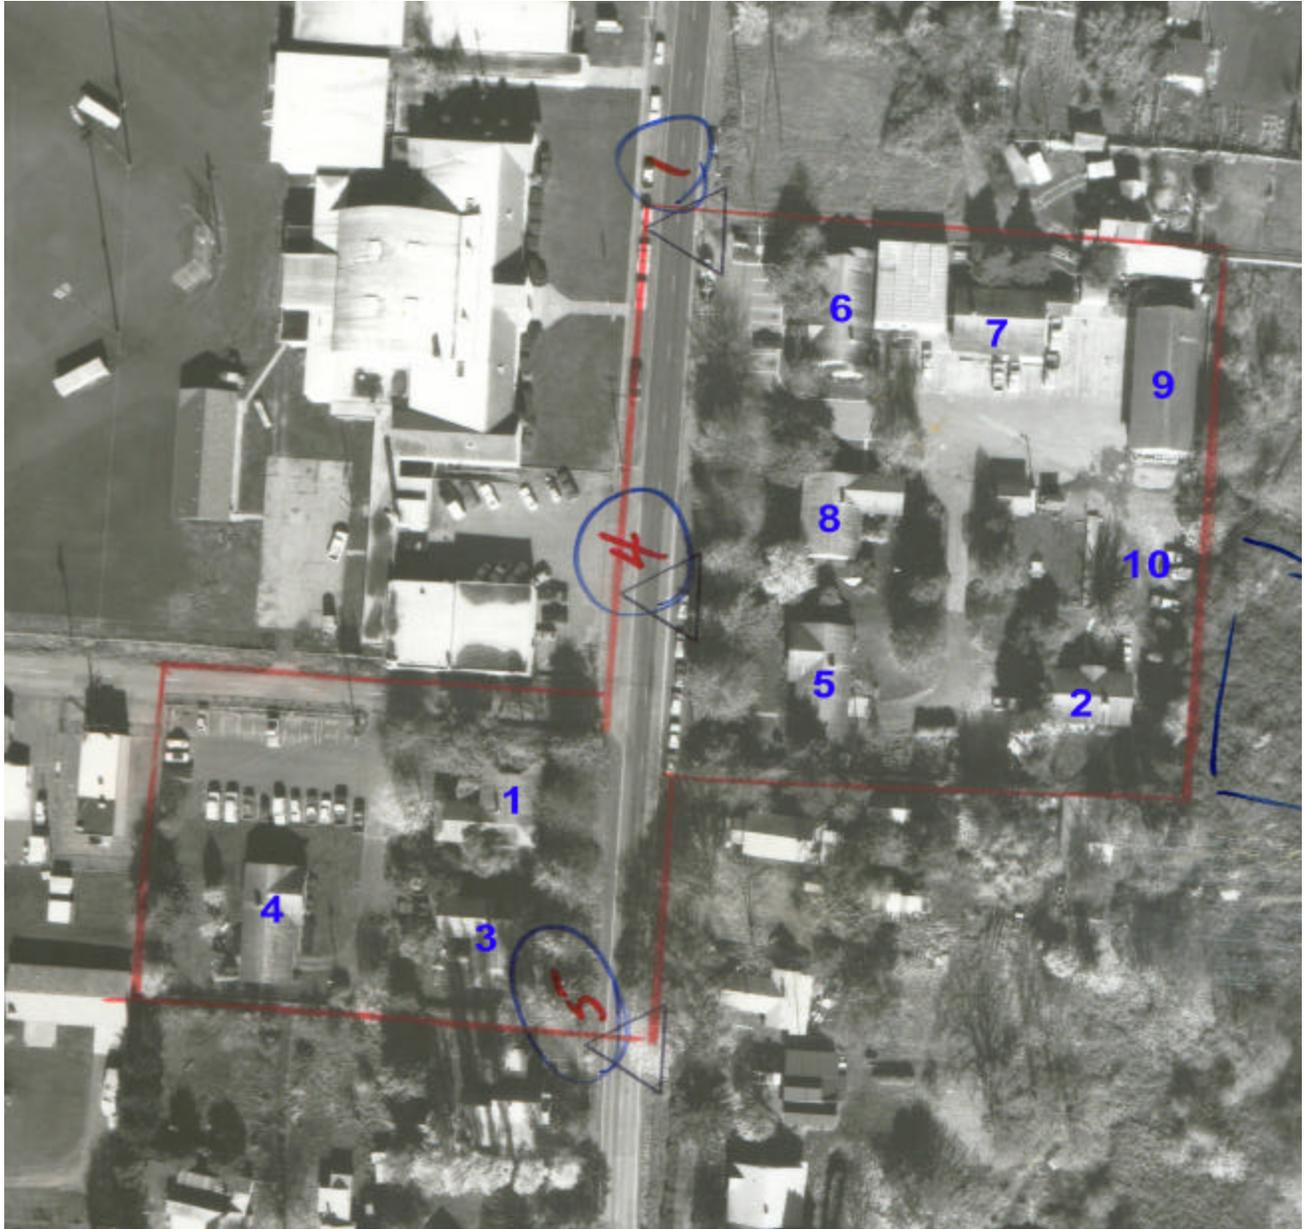
Figure 03. Aerial photo from 1979 showing the Lowell Ranger Station compound with blue numbers corresponding to the buildings and forms. Main Office is #6.

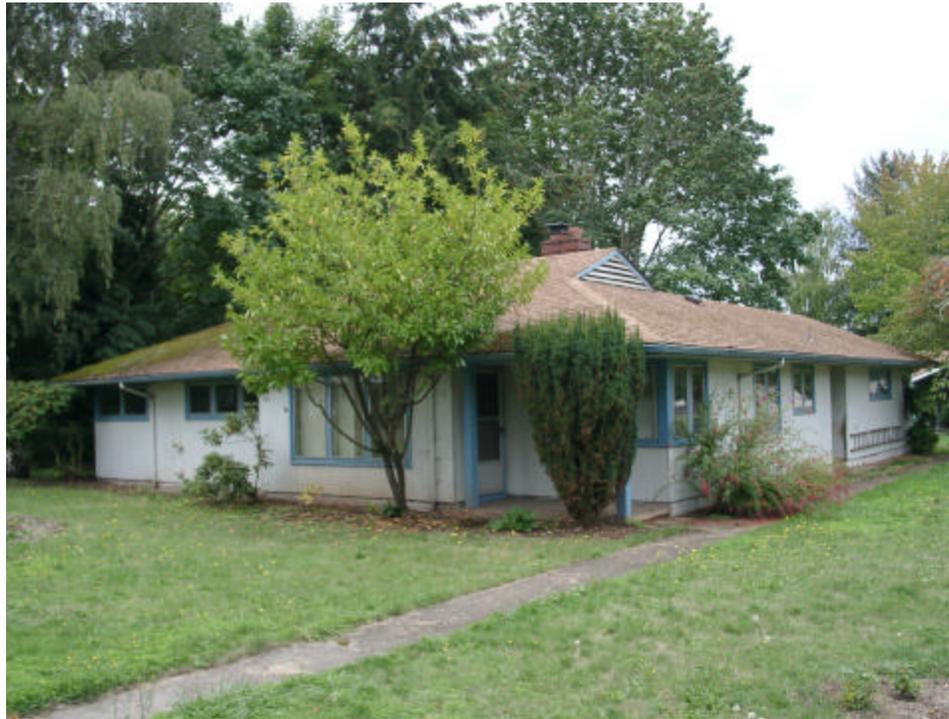
Number on Aerial: **1**

Current Use: Other - vacant	Date of Construction: 1953
Architectural Classification/Resource Typ Vernacular Northwest Regional / Government	Alterations: Garage door replacement; kitchen and bathrooms; furnace reconfig; aluminum storms
Window Type and Material: Single-pane, wood awning and wood casement	Exterior Surface Materials Primary: Board & batten Secondary: NA Decorative: NA
Roof Type and Material: Hipped gable (gabled) / Composition shingle	
Condition: <input type="checkbox"/> Excellent <input checked="" type="checkbox"/> Good <input type="checkbox"/> Fair <input type="checkbox"/> Poor	Integrity: <input checked="" type="checkbox"/> Excellent <input type="checkbox"/> Good <input type="checkbox"/> Fair <input type="checkbox"/> Poor

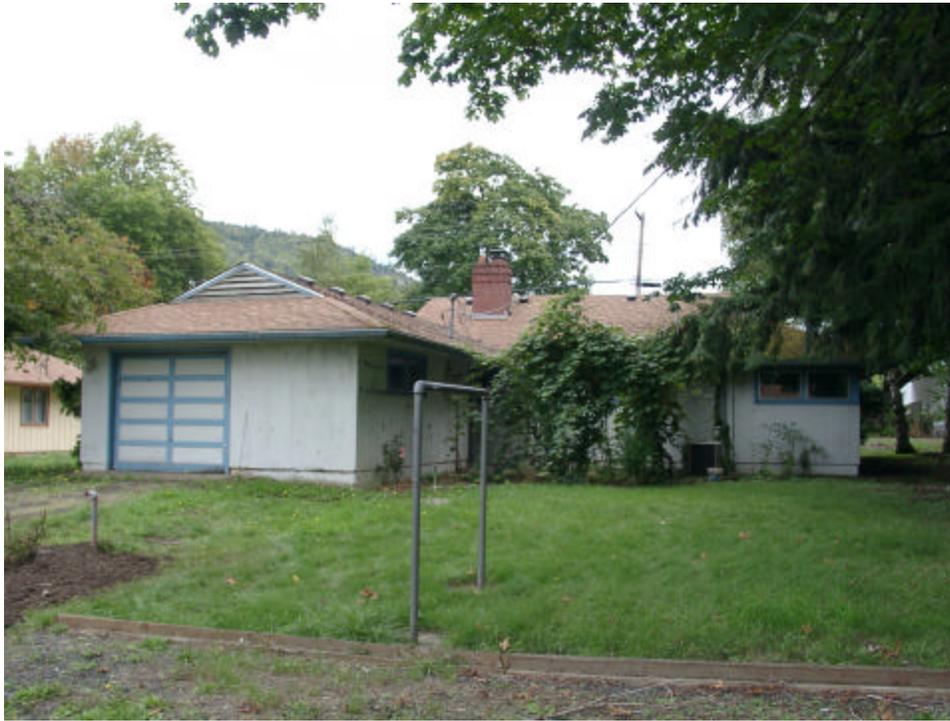
Rear view of building.

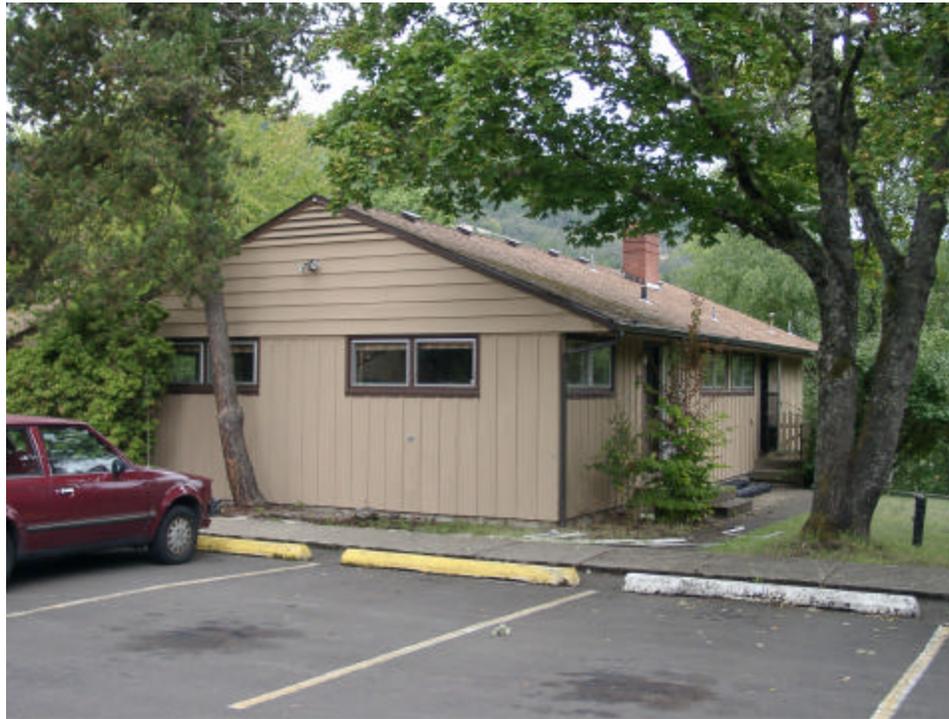
Number on Aerial: **2**

Current Use: Government - office	Date of Construction: 1953
Architectural Classification/Resource Typ Vernacular Northwest Regional / Government	Alterations: Interior reconfigured; aluminum storms
Window Type and Material: Single-pane, wood awning	Exterior Surface Materials Primary: Board & batten Secondary: Lap Decorative: NA
Roof Type and Material: Hipped gable (gabled) / Composition shingle	
Condition: <input type="checkbox"/> Excellent <input checked="" type="checkbox"/> Good <input type="checkbox"/> Fair <input type="checkbox"/> Poor	Integrity: <input checked="" type="checkbox"/> Excellent <input type="checkbox"/> Good <input type="checkbox"/> Fair <input type="checkbox"/> Poor

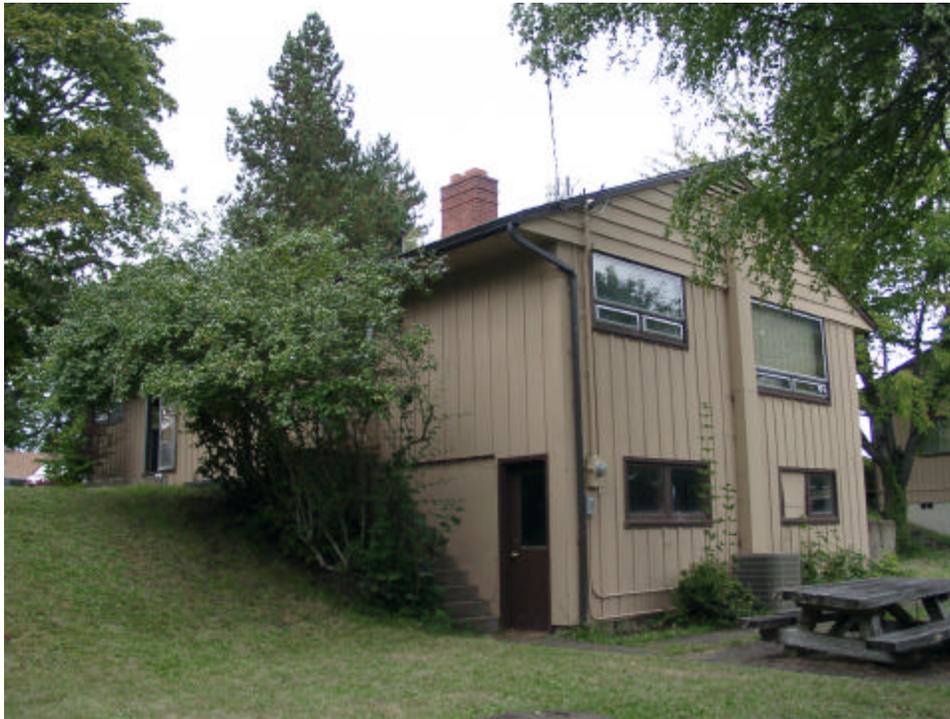
Rear view of building.

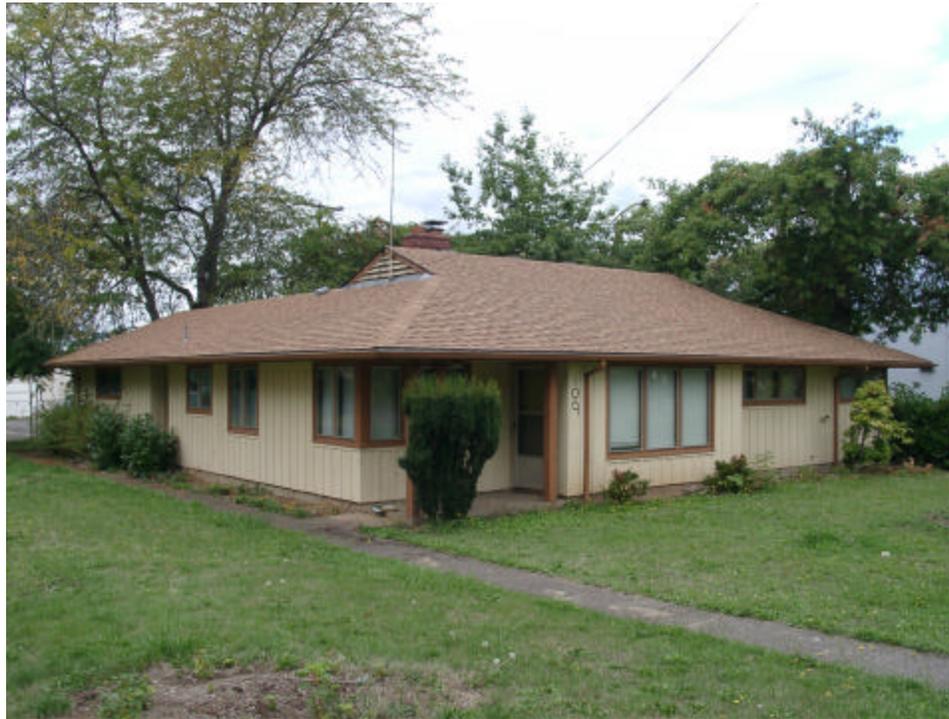
Number on Aerial: **3**

Current Use: Other - vacant	Date of Construction: 1953
Architectural Classification/Resource Typ Vernacular Northwest Regional / Government	Alterations: Garage door replacement; kitchen and bathrooms; furnace reconfig; aluminum storms
Window Type and Material: Single-pane, wood awning and wood casement	Exterior Surface Materials Primary: Vertical tongue & groove Secondary: NA Decorative: NA
Roof Type and Material: Hipped gable (gabled) / Composition shingle	
Condition: <input type="checkbox"/> Excellent <input checked="" type="checkbox"/> Good <input type="checkbox"/> Fair <input type="checkbox"/> Poor	Integrity: <input checked="" type="checkbox"/> Excellent <input type="checkbox"/> Good <input type="checkbox"/> Fair <input type="checkbox"/> Poor

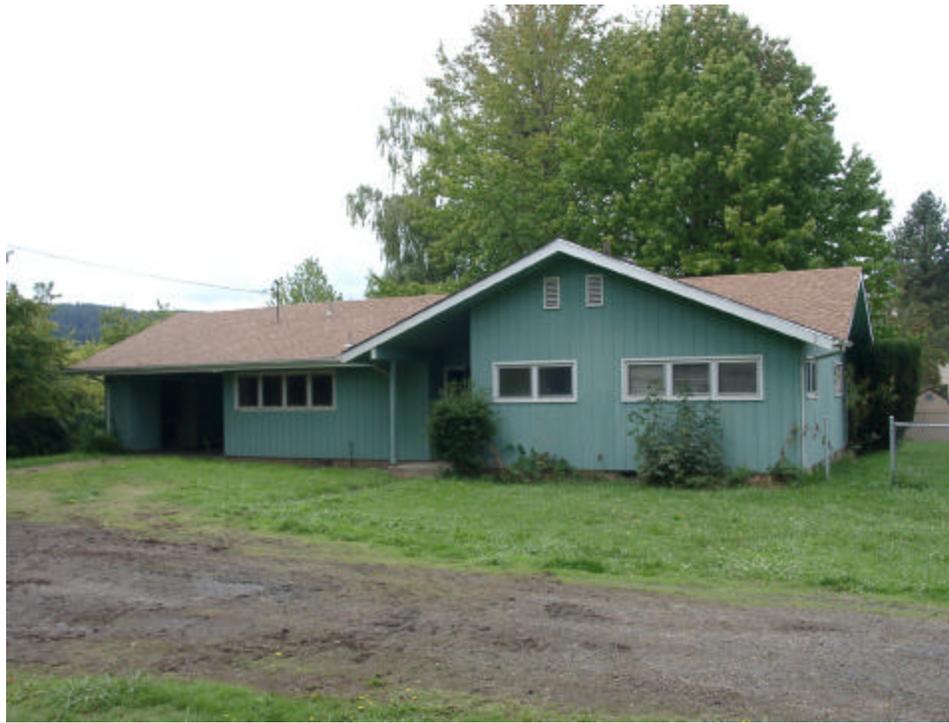
Number on Aerial: **4**

Current Use: Other - vacant	Date of Construction: 1959
Architectural Classification/Resource Typ Vernacular Northwest Regional / Government	Alterations: Kitchen and bathrooms; aluminum storms
Window Type and Material: Single-pane, wood awning and wood casement	Exterior Surface Materials Primary: Vertical rabbetted Secondary: NA Decorative: NA
Roof Type and Material: Gable / Composition shingle	
Condition: <input type="checkbox"/> Excellent <input checked="" type="checkbox"/> Good <input type="checkbox"/> Fair <input type="checkbox"/> Poor	Integrity: <input checked="" type="checkbox"/> Excellent <input type="checkbox"/> Good <input type="checkbox"/> Fair <input type="checkbox"/> Poor

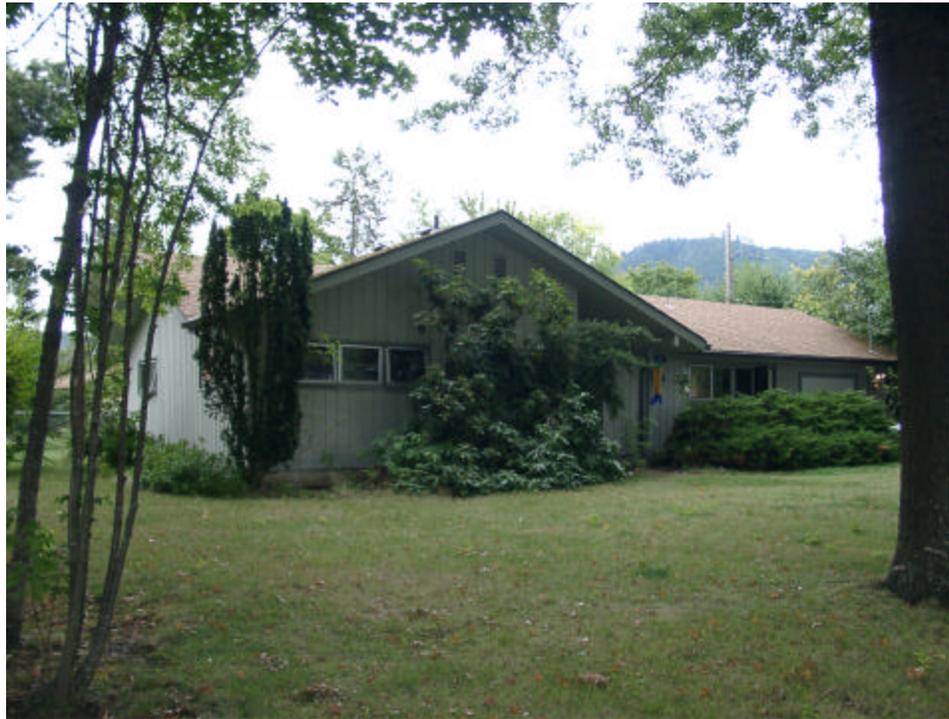
Number on Aerial: **5**

Current Use: Domestic - single dwelling	Date of Construction: 1959
Architectural Classification/Resource Typ Vernacular Northwest Regional / Government	Alterations: Enclosed carport space; aluminum storms
Window Type and Material: Single-pane, wood awning and wood casement	Exterior Surface Materials Primary: Vertical rabbetted Secondary: NA Decorative: NA
Roof Type and Material: Gable / Composition shingle	
Condition: <input checked="" type="checkbox"/> Excellent <input type="checkbox"/> Good <input type="checkbox"/> Fair <input type="checkbox"/> Poor	Integrity: <input type="checkbox"/> Excellent <input checked="" type="checkbox"/> Good <input type="checkbox"/> Fair <input type="checkbox"/> Poor

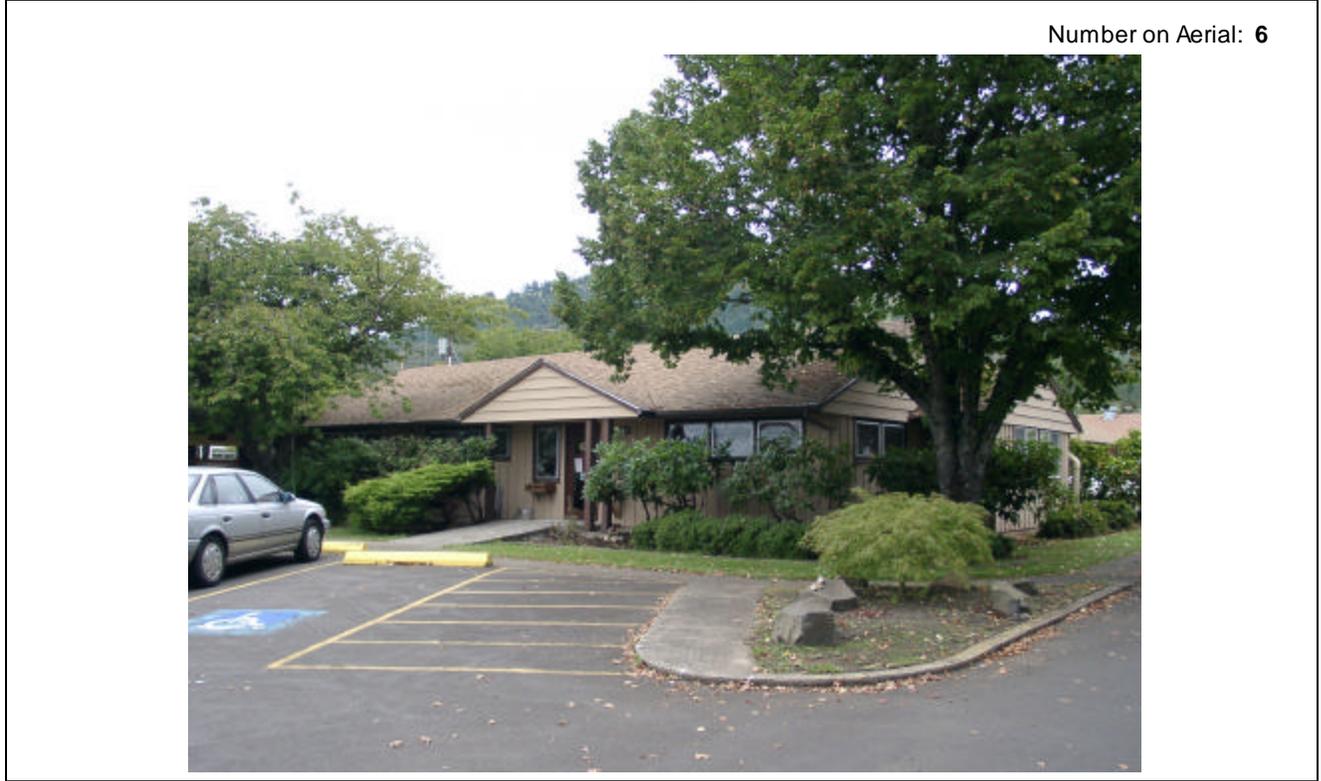
Current Use: Government - office	Date of Construction: 1953
Architectural Classification/Resource Typ Vernacular Northwest Regional / Government	Alterations: Extension of north end; interior reconfigured; aluminum storms
Window Type and Material: Single-pane, wood awning and wood casement	Exterior Surface Materials Primary: Board & batten Secondary: Lap Decorative: NA
Roof Type and Material: Gable / Composition shingle	
Condition: <input checked="" type="checkbox"/> Excellent <input type="checkbox"/> Good <input type="checkbox"/> Fair <input type="checkbox"/> Poor	Integrity: <input type="checkbox"/> Excellent <input checked="" type="checkbox"/> Good <input type="checkbox"/> Fair <input type="checkbox"/> Poor

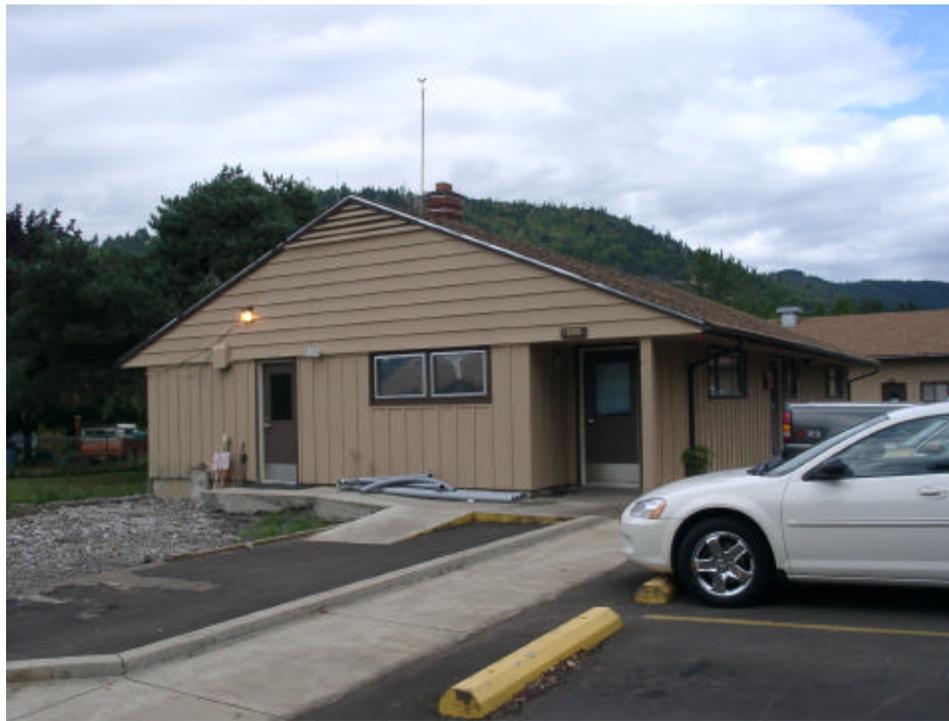
Number on Aerial: 7

Current Use: Government - office	Date of Construction: 1953
Architectural Classification/Resource Typ Vernacular Northwest Regional / Government	Alterations: Interior reconfigured; window replacement; aluminum storms
Window Type and Material: Aluminum sliders; vinyl sliders	Exterior Surface Materials Primary: Board & batten Secondary: Lap Decorative: NA
Roof Type and Material: Gable / Composition shingle	
Condition: <input type="checkbox"/> Excellent <input checked="" type="checkbox"/> Good <input type="checkbox"/> Fair <input type="checkbox"/> Poor	Integrity: <input checked="" type="checkbox"/> Excellent <input type="checkbox"/> Good <input type="checkbox"/> Fair <input type="checkbox"/> Poor

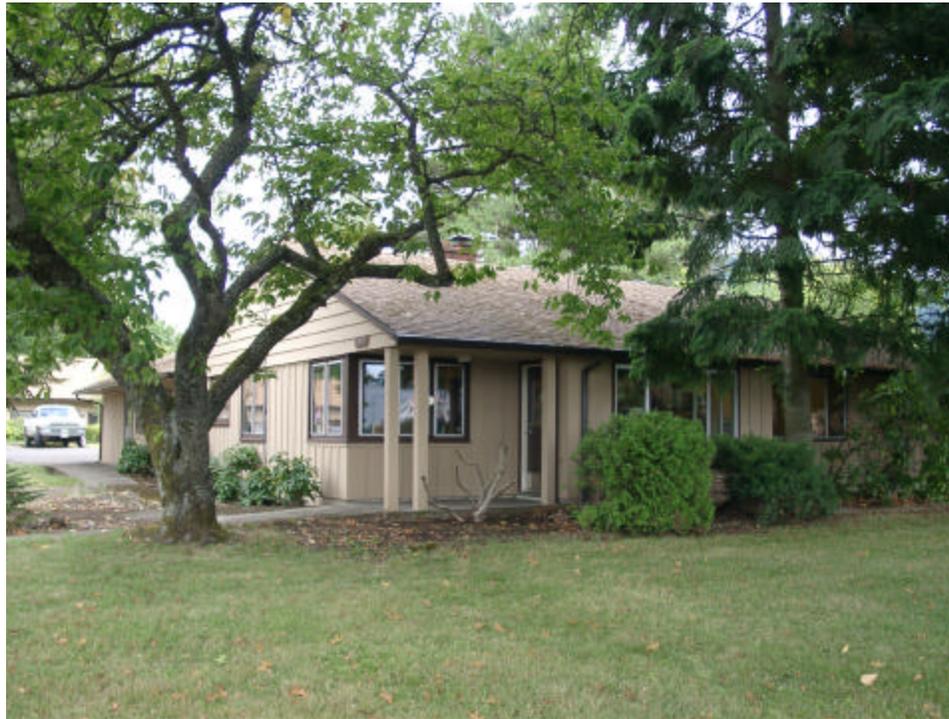
Number on Aerial: **8**

Current Use: Government - office	Date of Construction: 1953
Architectural Classification/Resource Typ Vernacular Northwest Regional / Government	Alterations: Addition on rear; window replacement on front; interior reconfiguration
Window Type and Material: Single-pane, wood awning and wood casement	Exterior Surface Materials Primary: Board & batten Secondary: Lap Decorative: NA
Roof Type and Material: Gable / Composition shingle	
Condition: <input type="checkbox"/> Excellent <input checked="" type="checkbox"/> Good <input type="checkbox"/> Fair <input type="checkbox"/> Poor	Integrity: <input type="checkbox"/> Excellent <input type="checkbox"/> Good <input checked="" type="checkbox"/> Fair <input type="checkbox"/> Poor

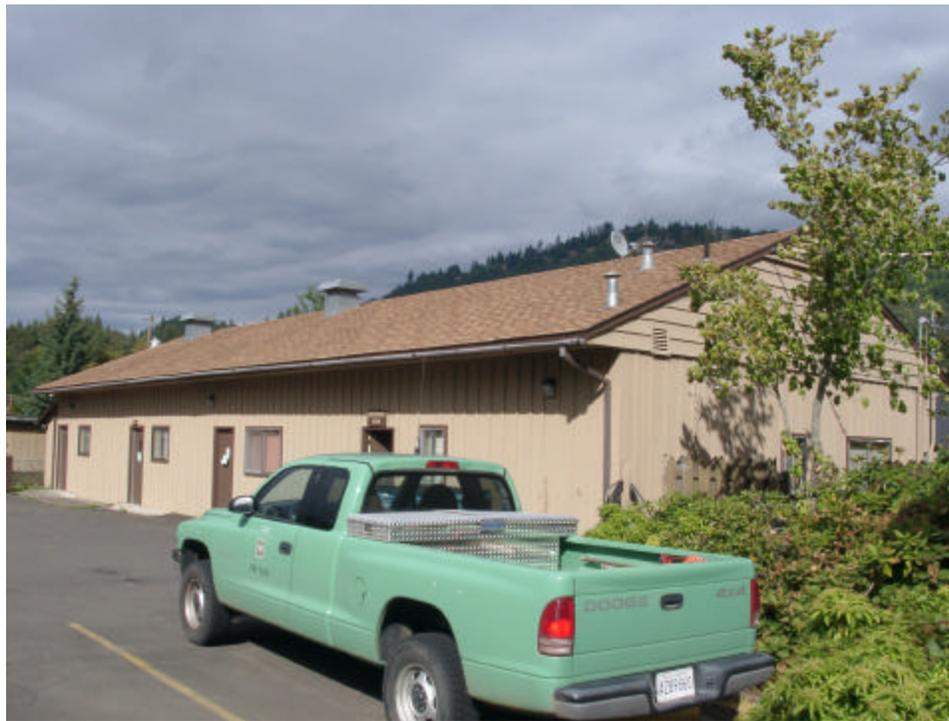
Number on Aerial: **9**

Current Use: Government - office	Date of Construction: 1953
Architectural Classification/Resource Typ Utilitarian / Government	Alterations: Four garage bays sided over; interior reconfigured
Window Type and Material: Aluminum sliders	Exterior Surface Materials Primary: Board & batten Secondary: Lap Decorative: NA
Roof Type and Material: Gable / Composition shingle	
Condition: <input checked="" type="checkbox"/> Excellent <input type="checkbox"/> Good <input type="checkbox"/> Fair <input type="checkbox"/> Poor	Integrity: <input type="checkbox"/> Excellent <input type="checkbox"/> Good <input type="checkbox"/> Fair <input checked="" type="checkbox"/> Poor

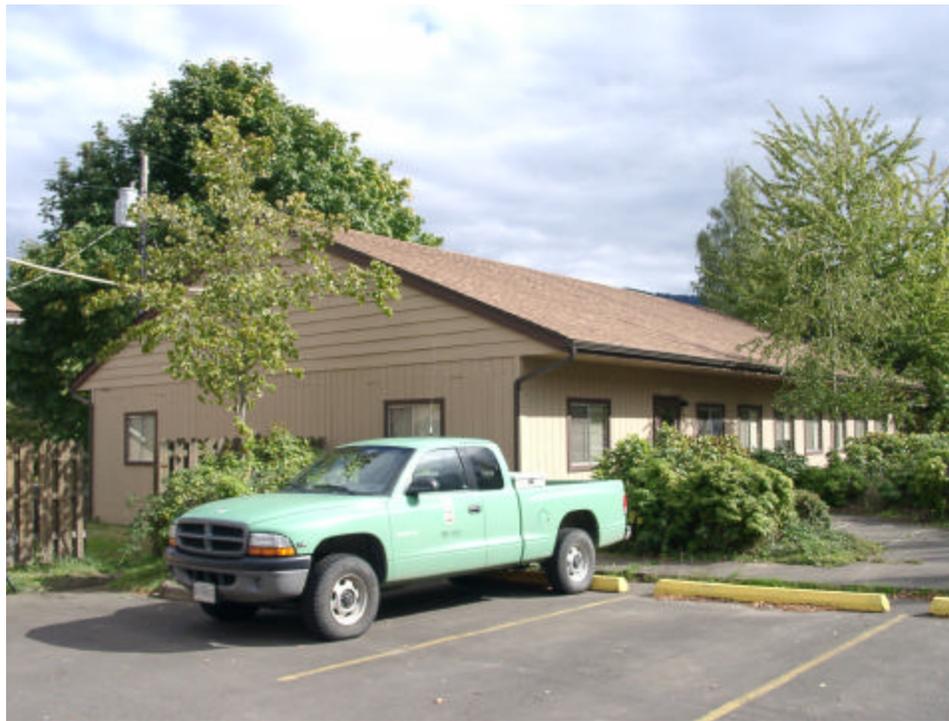
Number on Aerial: **10**

Current Use: Government - office	Date of Construction: 1981
Architectural Classification/Resource Typ Utilitarian / Government	Alterations: None apparent
Window Type and Material: Aluminum sliders	Exterior Surface Materials Primary: Vertical groove plywood Secondary: Lap Decorative: NA
Roof Type and Material: Gable / Composition shingle	
Condition: <input checked="" type="checkbox"/> Excellent <input type="checkbox"/> Good <input type="checkbox"/> Fair <input type="checkbox"/> Poor	Integrity: <input checked="" type="checkbox"/> Excellent <input type="checkbox"/> Good <input type="checkbox"/> Fair <input type="checkbox"/> Poor
