CHAPTER XI

PORT ORFORD STATION

Port Orford Lifeboat Station

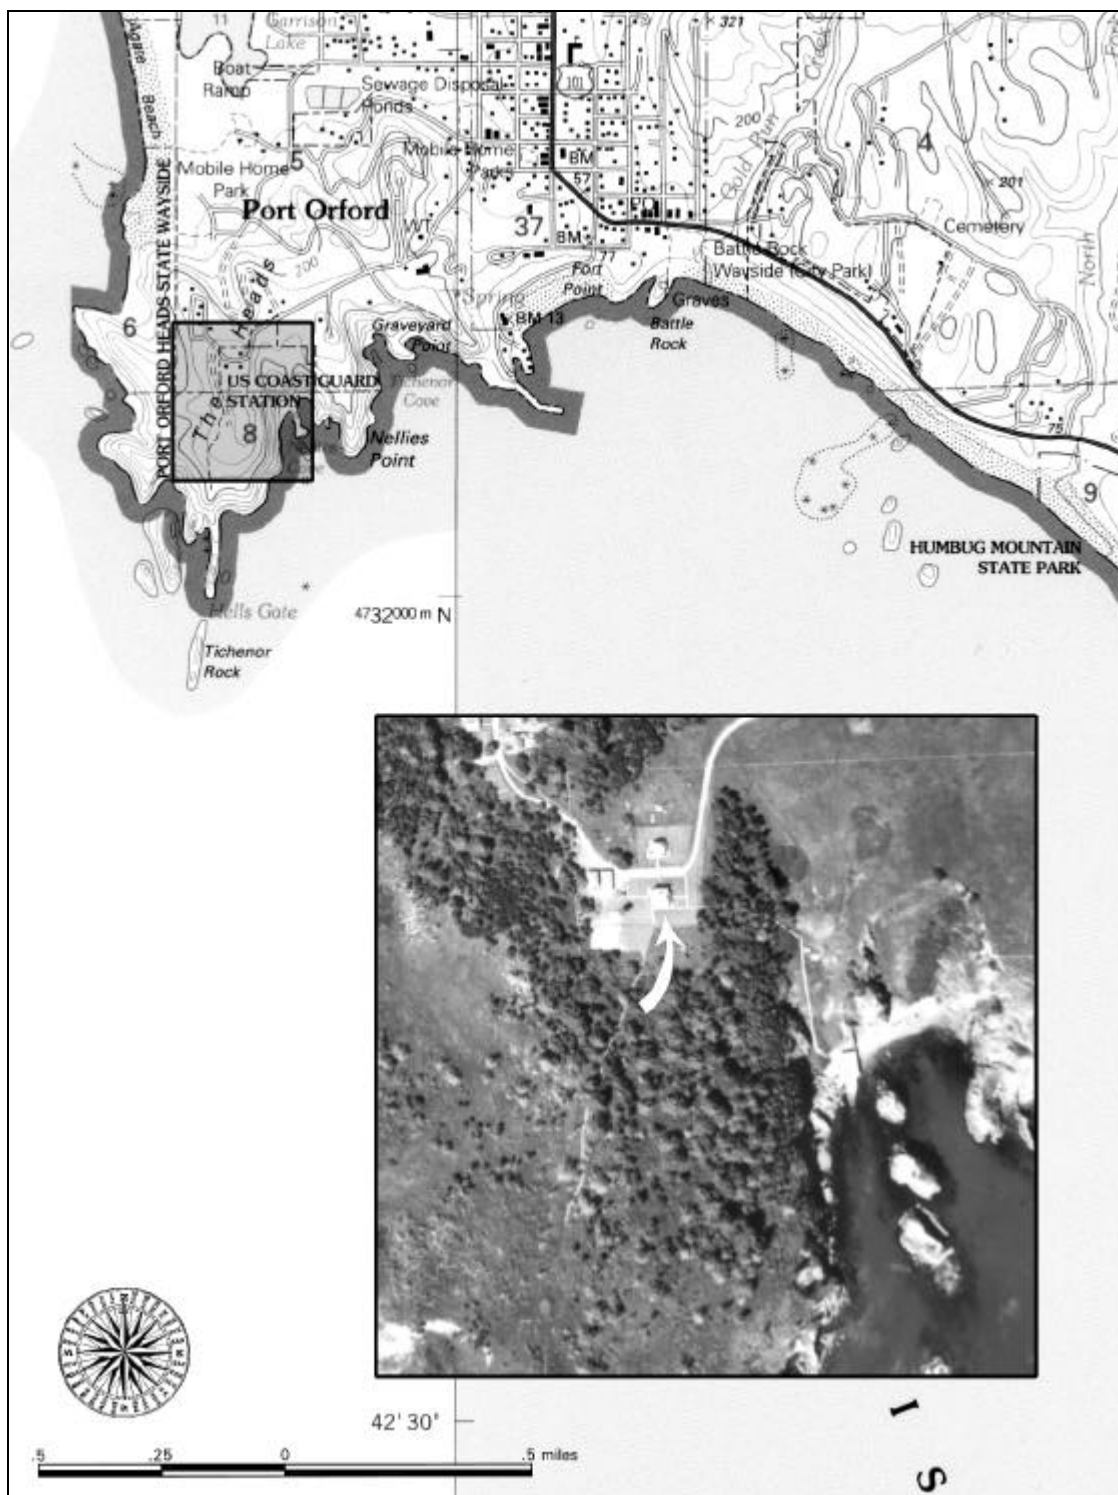
Figure 172. Aerial Photo of the Port Orford Station Area in 1939 Superimposed Over the Port Orford, Oregon, USGS Map (1996 Revision).

In July 1933, the *Curry County Reporter* gossiped about construction at the site and noted that the keeper’s dwelling and boathouse were well underway.²⁵⁸ The site chosen was a geographical feature known as “The Heads” (Figure 172) on the western edge of Port Orford. The prominent headland offered a wide view of the ocean and harbor at a vantage point 280' above the water. Contractors on the project were Ovid

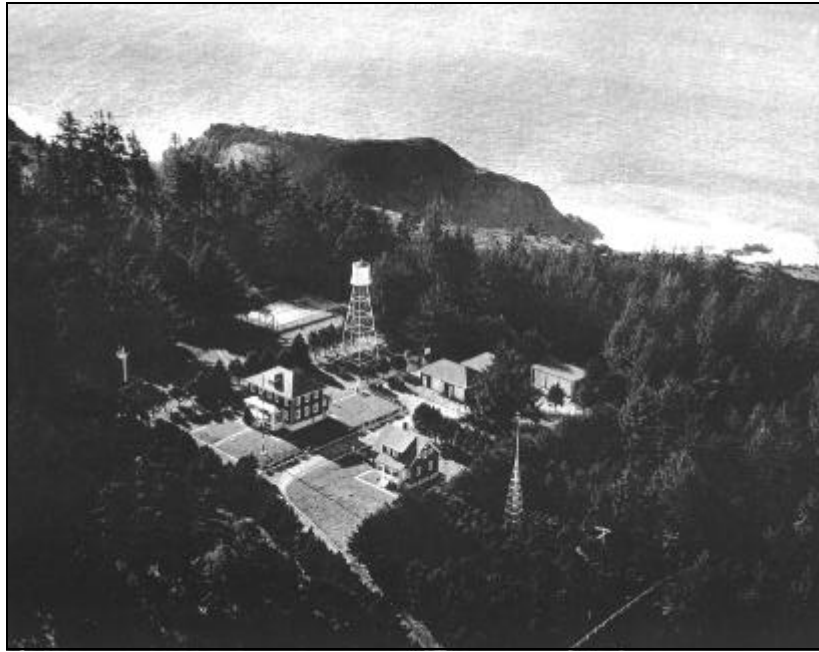
Figure 173. Port Orford Lifeboat Station, 1954. Source: National Archives (RG 26-DS Box 21 Folder 437).

Olson and Julius Yuhasz.²⁵⁹ On 1 July 1934, the station was commissioned and put into service (Figure 173).²⁶⁰

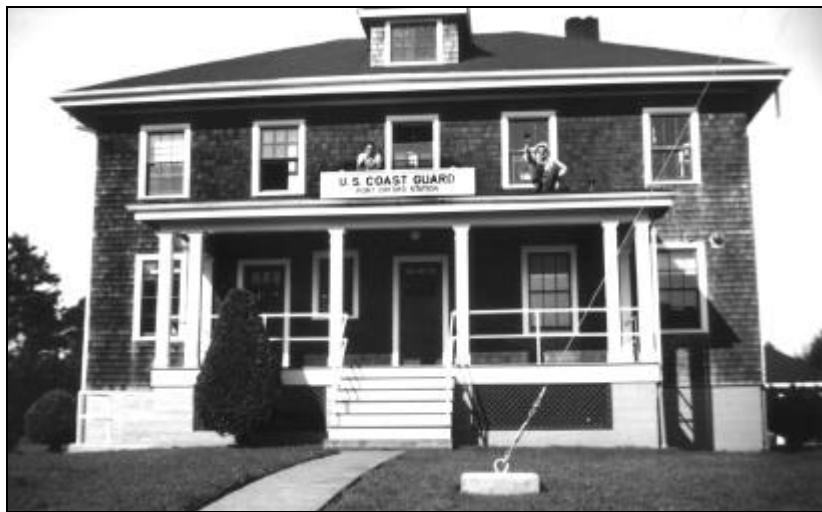
Figure 174. Station House, Port Orford Lifeboat Station, Circa 1940. Source: Oregon State Historic Preservation Office (Port Orford File).

The station house built at Port Orford is known as a late Chatham-type (Figure 174). The original Chatham-type was designed by Victor Mindeleff in 1914 for the life-saving station at Chatham, Massachusetts. It is not known who designed the Port Orford station, but the plans did not drift too far from the original Chatham design. At least 30 Chatham-type stations were built on both East and West Coasts marking the first time since the Marquette-type stations of a standard, nationwide architecture. Variations on the Chatham-type station continued to be constructed through the 1930s.²⁶¹ In the mid-1930s, the Coast Guard began to transition to the Roosevelt-type stations.

The station house was symmetrical, 45' wide and 30' deep, slightly larger than the early Chatham stations. The elevations were clad entirely in unpainted shingles pierced by six-over-six, double-hung windows. As had been the trend since 1900, Colonial Revival details became less prominent to the point where the symmetry of the front facade and classically detailed porch columns were the only Colonial elements remaining. The late Chatham-type station marks the bottom of this gradual decrease in ornament. With the Roosevelt-type station that follows the Chatham, there was a short-lived resurgence of Colonial decoration.

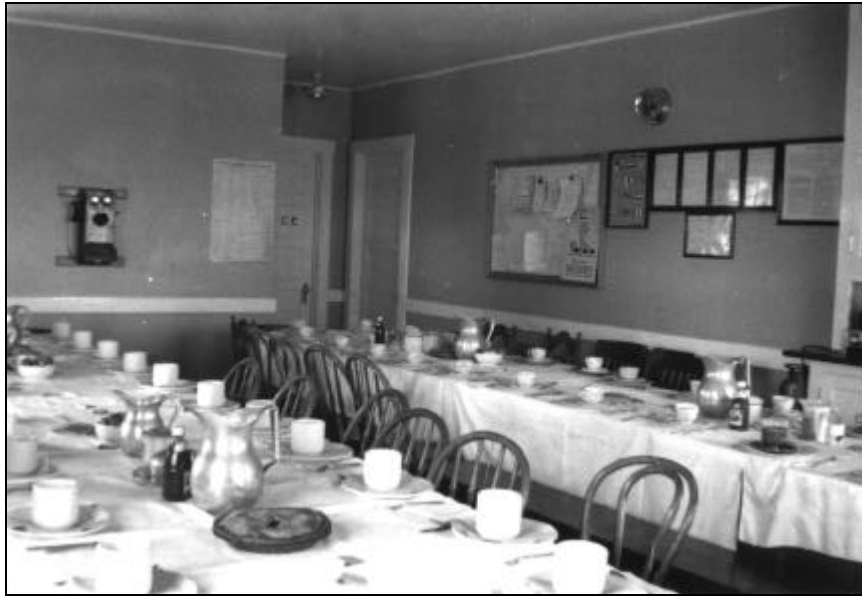
Figure 175. Mess Room, Port Orford Lifeboat Station, Circa 1940.
Source: Oregon State Historic Preservation Office (Port Orford File).

The Port Orford station house is elevated on a high concrete basement. The two-story building is capped with a hipped roof sporting two dormers. The front porch is nearly full-width with a concrete floor and metal pipe railing. The porch roof is hipped and supported by Classical, square posts. From the front porch there are two entries. The one on the right goes into the mess room (Figure 175), while the other door heads directly into the Officer in Charge's (OIC) office. Across the back of the building is the kitchen, spare bedroom, and OIC bedroom and bath (Figure 176). There is a back door in a vestibule off the kitchen. On the second floor is a large bedroom, four smaller bedrooms, and one bathroom (Figure 177). The attic is accessed by a pull-down stair and was designed for storage. During WWII, the attic was used as bunk space. The basement has rooms for storage, laundry, provisions, storm clothes, and coal.

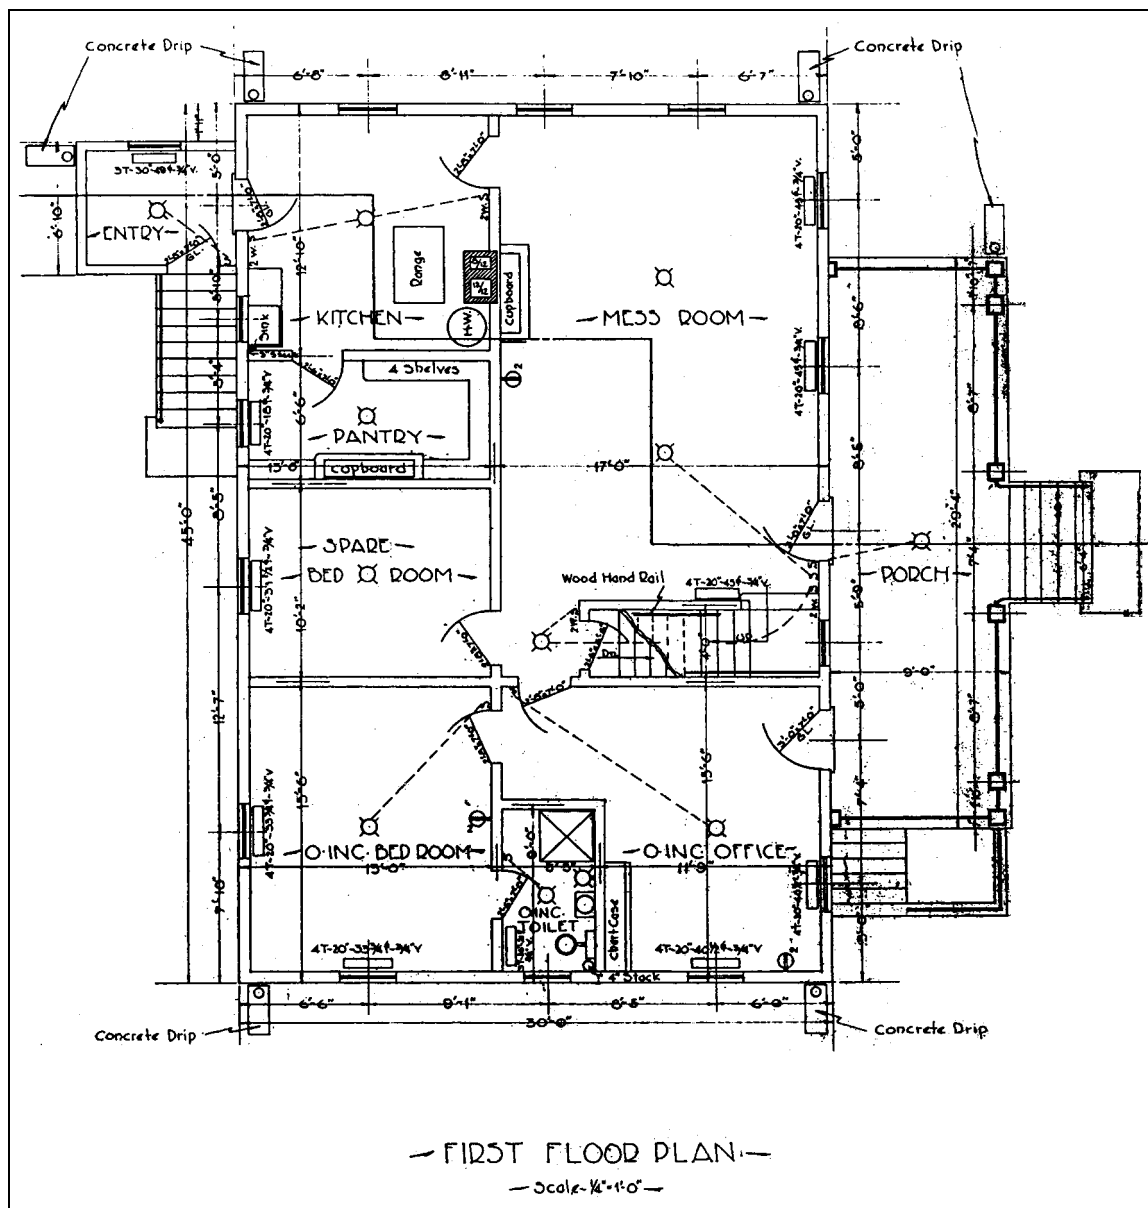
Figure 176. First Floor Plan, Port Orford Lifeboat Station. Source: State Historic Preservation Office (Port Orford File).

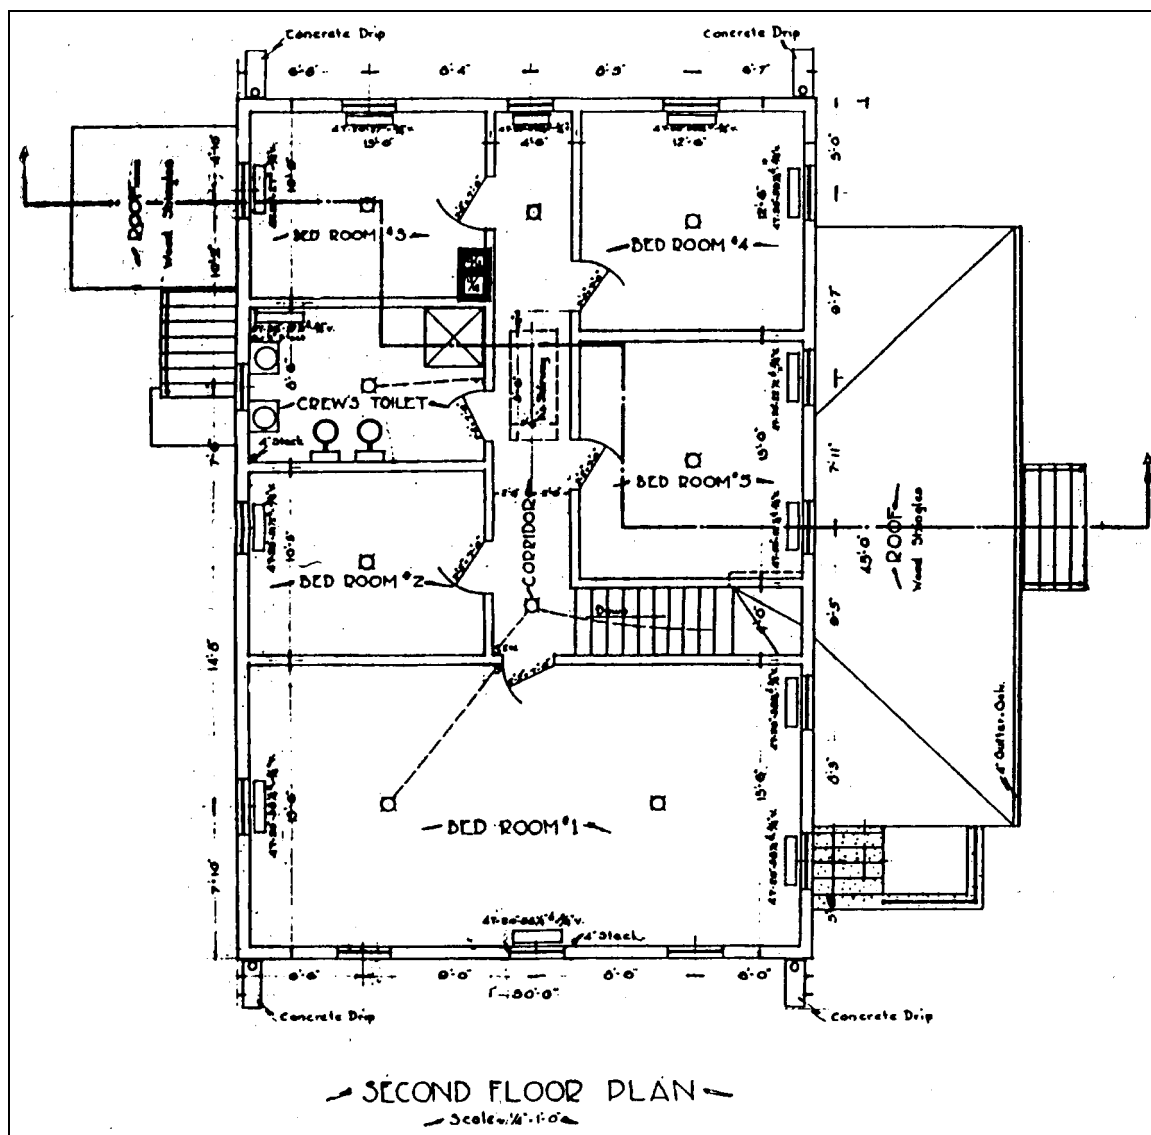
Figure 177. Second Floor Plan, Port Orford Lifeboat Station. Source: Nautical Research Centre (#11-63a).

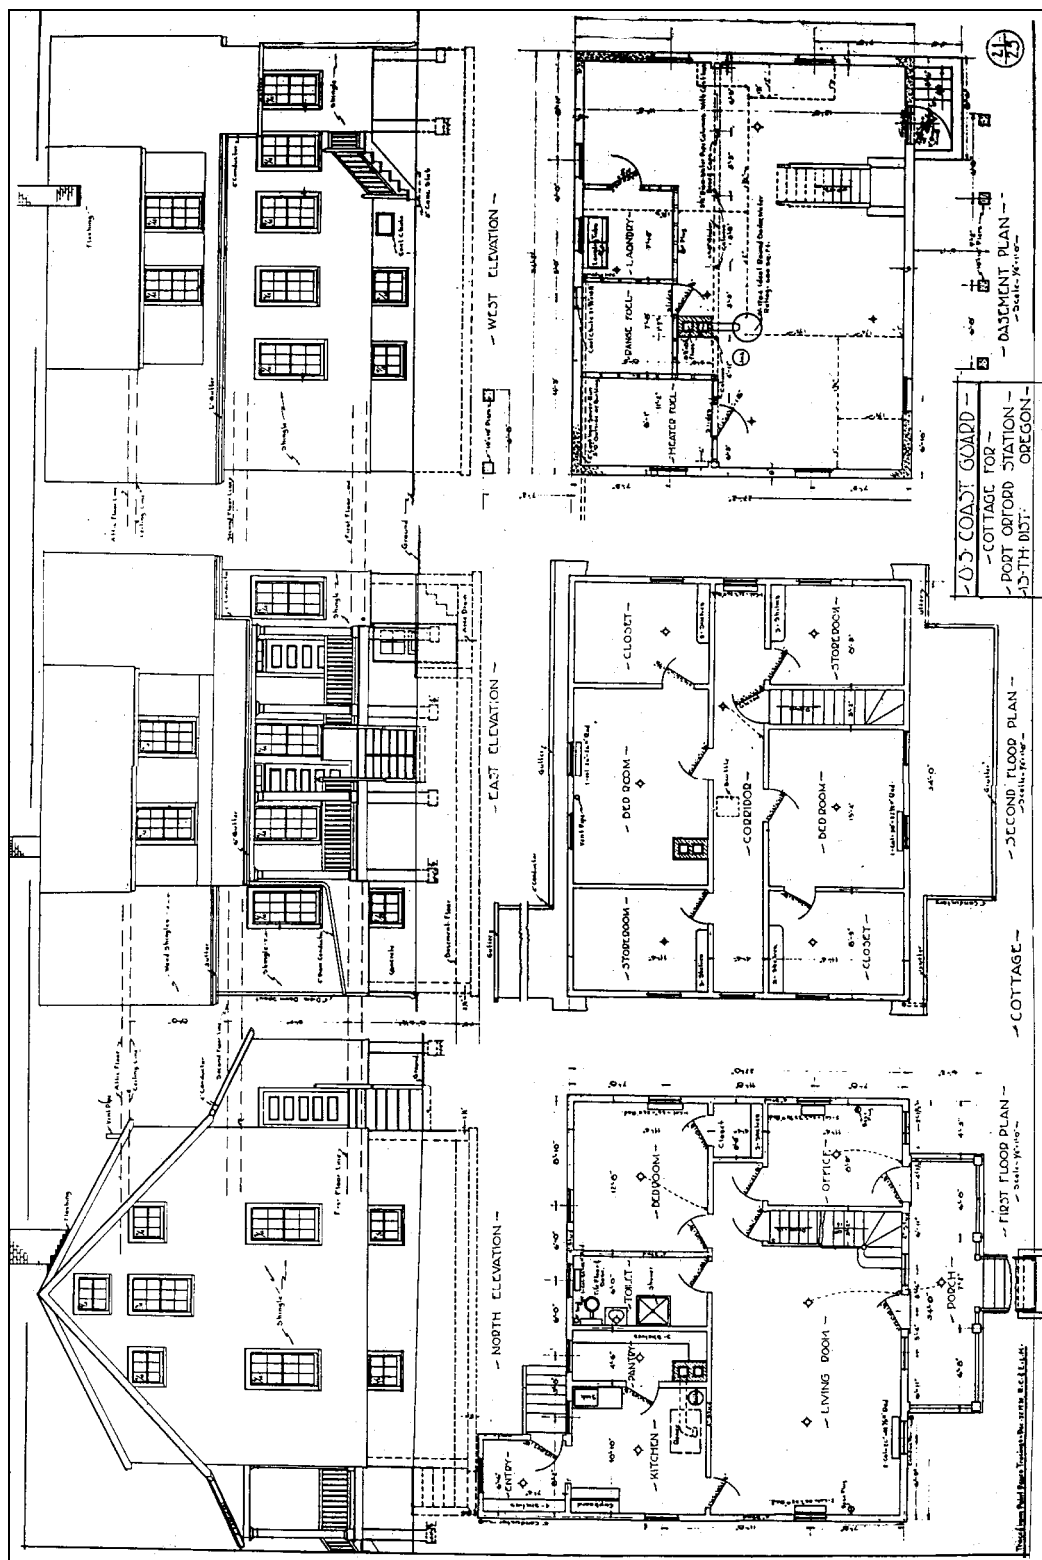
Figure 178. Keeper's Cottage, Port Orford Lifeboat Station. Source: Nautical Research Centre (#11-53).

The keeper's house was built north of the station house. The building is 1-1/2 stories, topped with a gable roof and two large shed dormers (Figure 178). The plans for the building note that they were traced from the keeper's house built at Point Reyes, California. Like the station house, the structure is clad in shingles, pierced by six-over-six, double-hung windows. The plan is 34' wide by 27' deep with a living room, office, bedroom, kitchen, and toilet on the first floor. The second floor has two bedrooms, two large walk-in closets, and two store rooms. The basement has two fuel rooms and a laundry room.

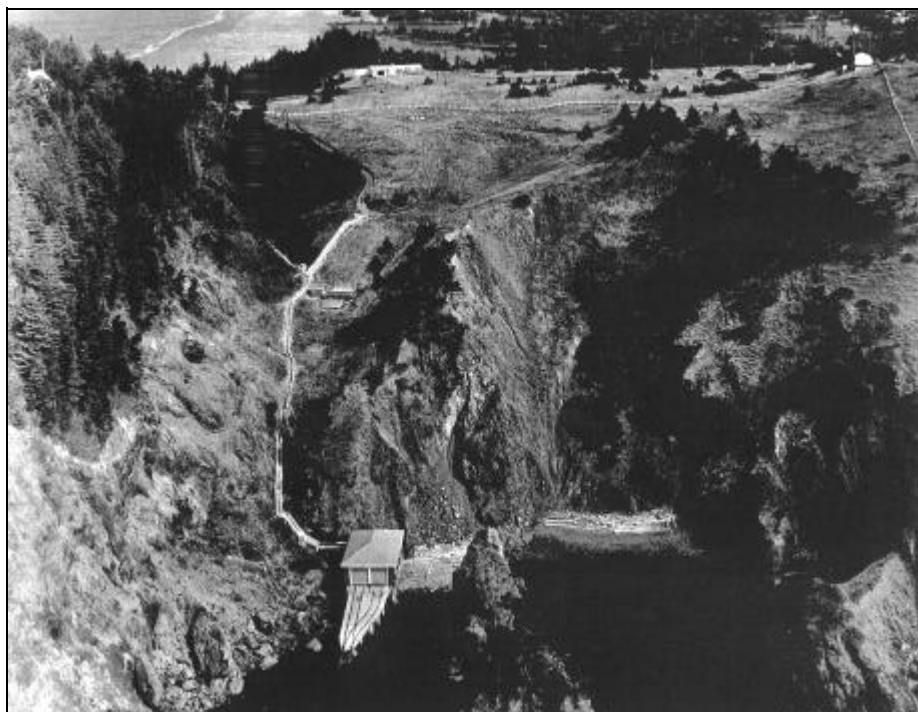
Figure 179. Boathouse in Nellies Cove, Port Orford Lifeboat Station, 1959. Source: National Archives (13CGD-081659-8).

The boathouse had the most unusual siting of any Coast Guard boathouse in Oregon. It was situated on the water at Nellies Cove, 280' below the station house (Figure 179). The 532-step staircase used to reach the boathouse was known as "The Stairs of a Thousand Tears." Materials were brought in by an aerial cable strung between

the top of the headland and the jagged rocks, called the Three Sisters, in the middle of the cove.²⁶² The boathouse was 36' wide by 60' deep, was two bays wide, and was capped with a hipped roof. The building was clad in shingles and punctuated by four, six-over-six, double-hung windows on either side and one on the rear of the building. The boathouse was entered from a door on the back. The boatroom doors were metal roll-ups. Rails left each boat bay and joined together in a single set leading down the launchway and into the water. Apparently a storm damaged the boathouse and

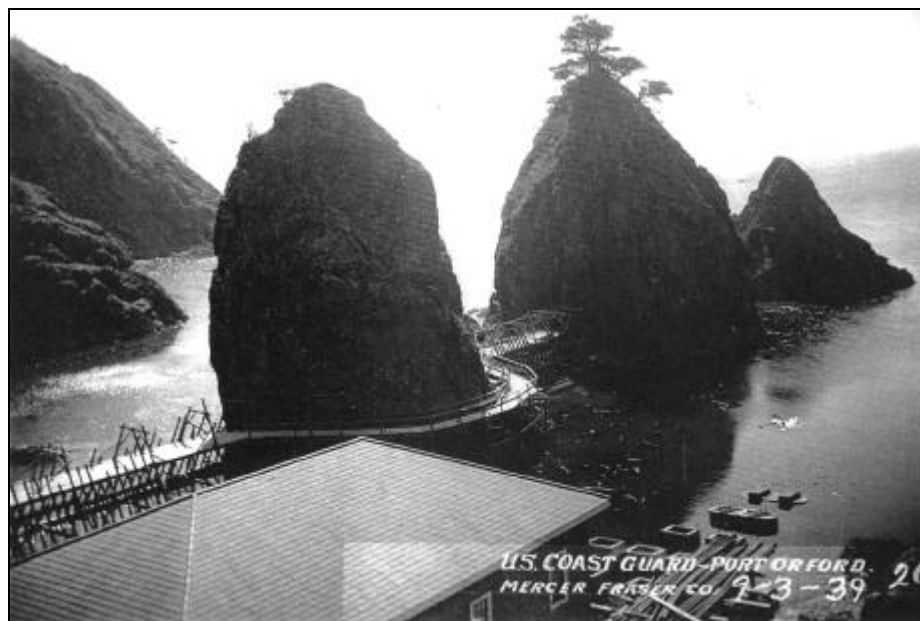
Figure 180. Boathouse Launchway and Breakwater Under Construction, 1939. Source: National Archives (RG 26-DS Box 21 Folder 437).

launchway extensively in 1939. As a consequence, enormous concrete breakwaters were built to divide Nellies Cove in two and give more protection to the boathouse (Figure 180). The launchway was also rebuilt at this time using concrete caissons for pilings. Unfortunately, the boathouse burned down in the 1970s and all that remains are the concrete caissons and remnants of the launchway.

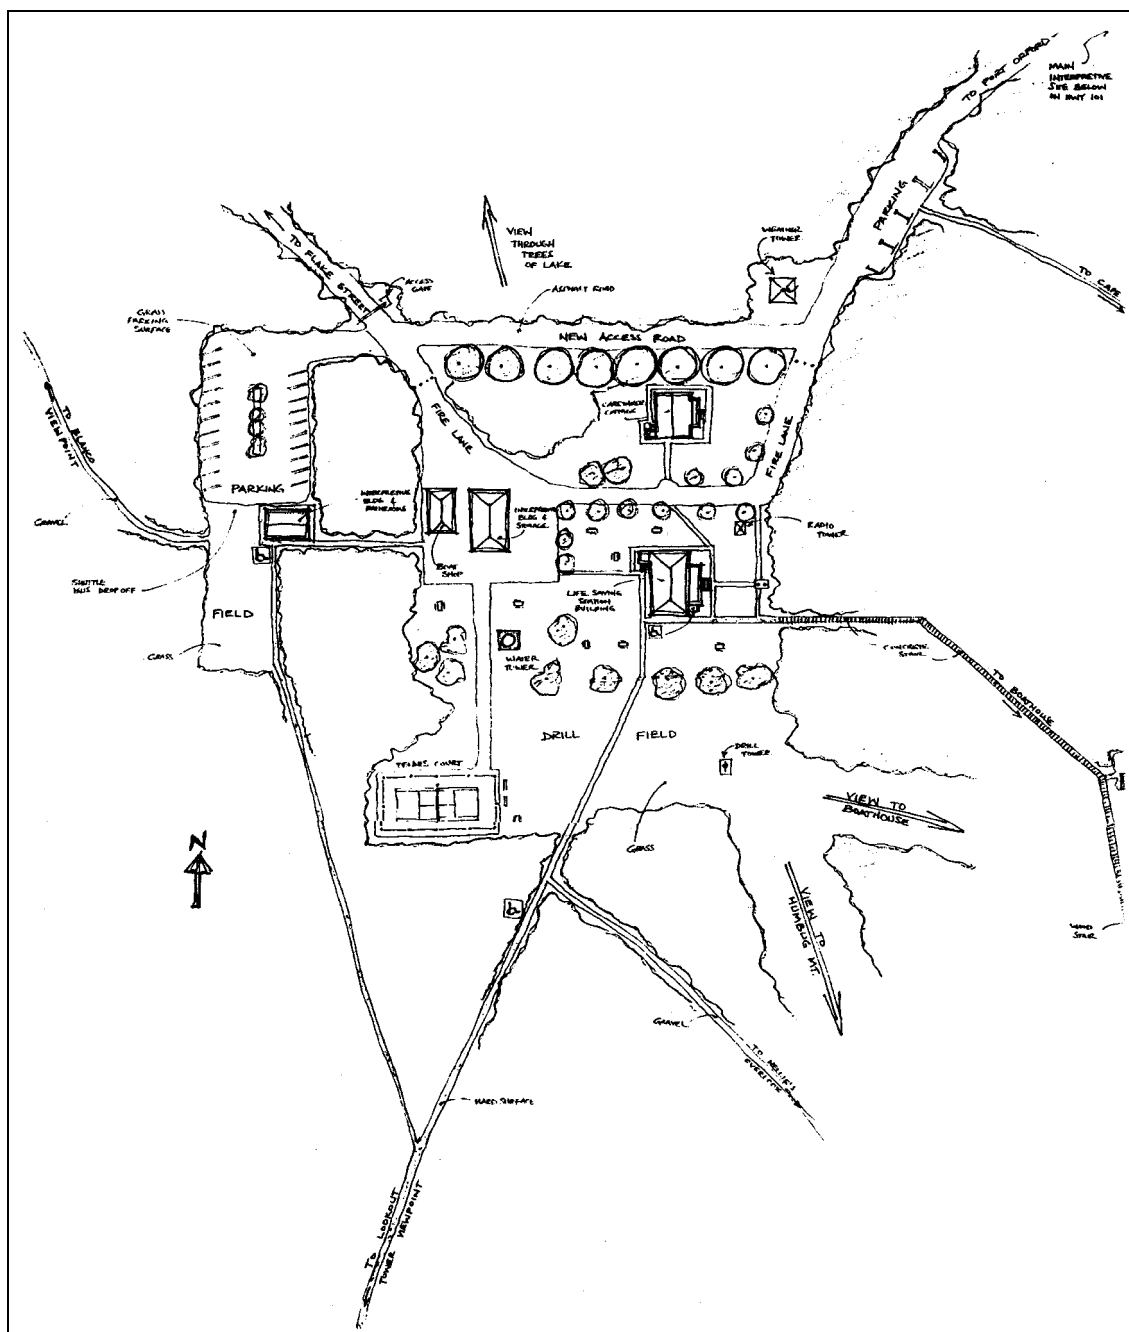
Figure 181. Proposed Site Interpretation and Development at the Port Orford Lifeboat Station by Mark Stinnette, 1996. Source: Author.

station complex was deeded to Oregon State Parks in 1976. Oregon State Parks in turn opened the site as the Port Orford Heads State Park.²⁶³ In 1996, the University of Oregon held a historic preservation field school at the station creating an interpretive plan for the site during the second week (Figure 181) and reconstructing dormer windows during the third week. In 1998, the standing elements of the station complex (five buildings and six structures) were added as a district to the National Register of Historic Places.
