# A.T. Smith House Historic Structures Report

Prepared for Friends of Historic Forest Grove by

Historic Preservation Northwest

August 31, 2007

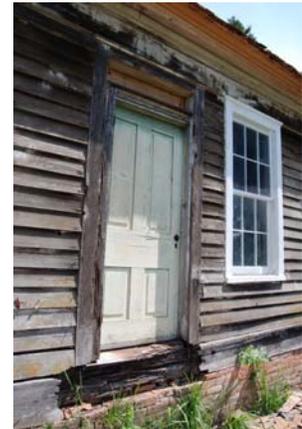
The east (front) and north doors are in excellent condition. The east door has been restored and the north door has been rebuilt in-kind. The west door is in good condition but the door surround needs attention (see image 1041). Specifically, the sill below the door is exposed and desiccated, with signs of past insect boring. There are no steps leading up to this door. According to the February 6, 2006 meeting notes of the A.T. Smith Committee, a prior assessment stated the sill at the west door was deteriorated but that there was solid wood at a depth of 1/8". The current assessment did not probe into the sill, so this cannot be confirmed or contested.

The sill under the west door should have a Dutchman repair, then the water table, threshold and steps can be reconstructed. A Dutchman repair would involve cutting out the portion of the sill plate that is extremely desiccated and eaten away, the portion that is no longer able to fulfill its structural role. A replacement piece of the same dimensions and material would be ideal (i.e., "in kind").

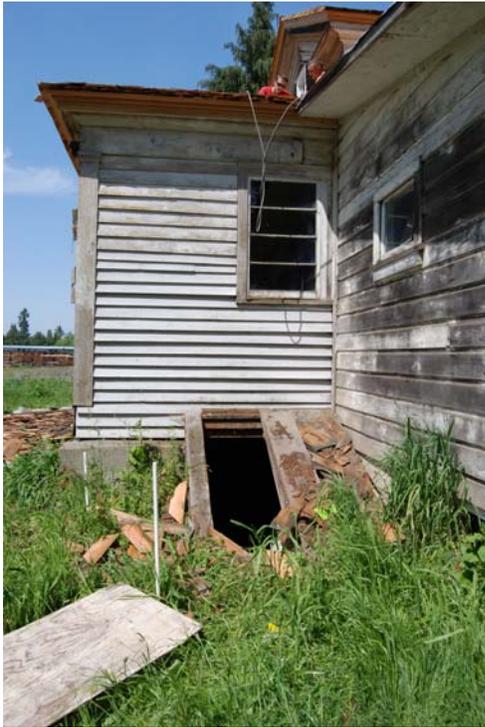
The exterior basement entrance on the southwest corner of the house was probably installed after 1934, though the HABS photos are inconclusive on this topic. Since it is the only exterior entrance to the basement and is formed out of concrete, it should be kept and a new pair of doors made to cover the entrance stairs. This cover should be in keeping with the house but does not have to recreate a specific period. Eventually, this entrance could be removed along with its concrete and the entrance out the west wall recreated; however, this is a very long term project.

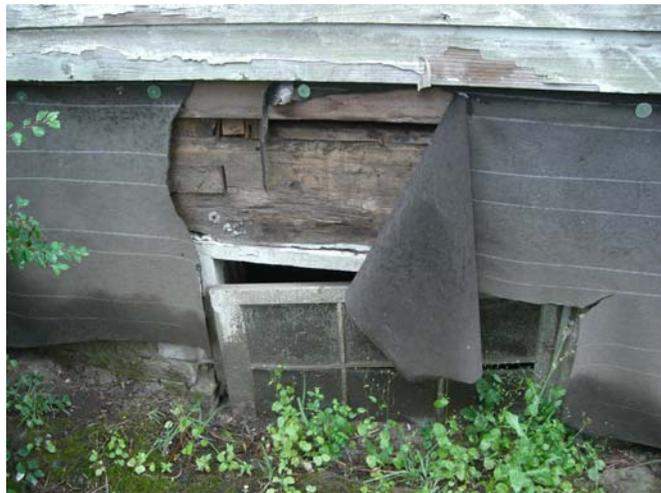
The opening at the basement window along the north elevation should be filled in before the start of the next rainy season. With regard to the south elevation hole, it should be filled in to discourage entry for small animals which could wreak their own havoc.

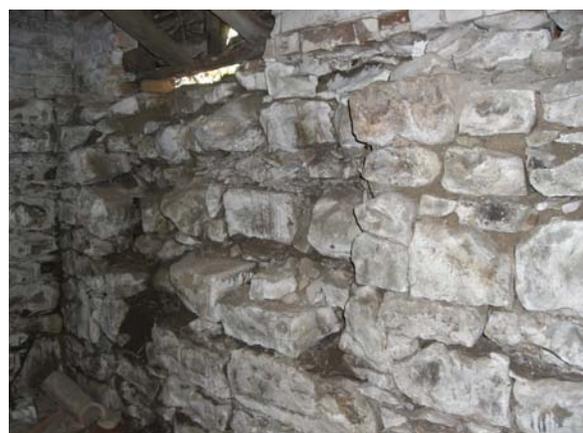
Todd Taylor recommends rebuilding the stone foundation wall and sticking the dry stone method, as it is integral to the A.T. Smith House’s story. When the building is lifted for leveling, masons should move in to rebuild in-kind the stone walls.

Proper posts should be inserted at the four intersections of the beams. These should be large, at least 6"x6", if not physically required, at least visually required. Douglas fir would be the best material and would be somewhat obviously not original to the structure. The footing pads for the posts should be large, perhaps 3'Lx3'Wx6"H, to spread the load and prevent sinking. A small raised portion of concrete, about 6"Lx6"Wx2"H, should be centered on the concrete pad to create a plinth for the post. The pad should be installed at grade so that the floor grade will hide the concrete and expose just the plinth. The post should then sandwich a composition shingle between it and the concrete to prevent wicking up the post.

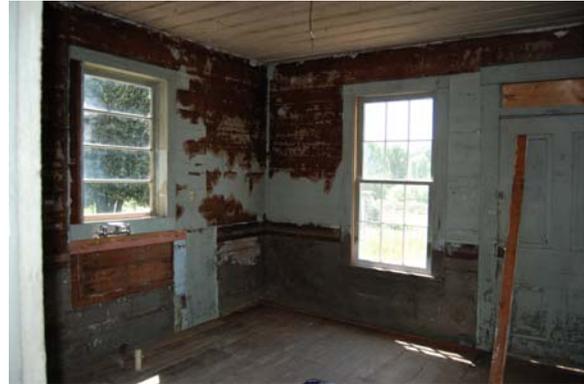
The SW Room (102) served as a laundry room but its original purpose is unknown. Most likely it was used as a generic work room. The room is 11'8" north-south and 12'2" east-west, creating a basically square room. The ceiling is 8'10" from the floor, clad with channel drop siding with a 8-3/4" exposure running north-south, and painted beige. This room is the only one in the house with a channel drop siding ceiling and an unusual ceiling treatment in any house.

The sheathing on the walls ranges from 8-3/4" to 5-1/2" tongue-and-groove boards. The upper two-thirds of these walls were covered in a cardboard-like cladding (1/16" thick gray paper) and then wallpapered. Most of the cardboard and wallpaper has been removed, though the south and west walls still have some blue-painted paper remaining. Most likely the upper two-thirds of these walls were originally covered in muslin and wallpapered. The lower third of the wall appears to have been painted. Over time, a variety of colors have been applied. Today there are remnants of gray, pink, sky blue, and green on the walls.

The flooring ranges from 5" to 6-1/4" wide, runs east-west, and is unfinished. The floor is decayed in the southwest corner and near the north wall. A bit of the kitchen's (Room 103) floor's underlayment stretches into this room through the east wall at the south end. There is no baseboard.

The most pressing decision for the SW Room (102) is what to do about the open east wall. We highly recommend filling in the southern opening. This would give the opportunity to reinsert the diagonal brace that was removed to make way for a refrigerator. The middle opening should also be filled and its casing removed. Two doors alongside of each other adds an inexplicable story that does not need to be told. As with the foyer wall, restoring the wall here will change the space drastically. Restoration would be as simple as inserting studs marked with the current date and resheathing with rough-sawn boards also dated on the back side.

The lack of floor treatment should not be a concern. It appears that it never had one and should remain without a treatment. The two areas of floor decay should be restored in-kind. Restoring the ceiling finish to the unusual ceiling would also be a long-term item.

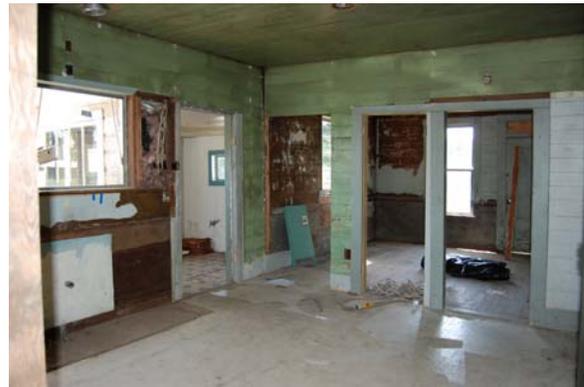
The Kitchen (103) measures 11'11" north-south and 13'10" east-west, making it nearly square. However, visually the room appears much longer along its east-west axis, because the walls on the east and west sides have been punctured and/or dismantled. The ceiling is 8'10" from the floor, clad with 1"x3-1/4" tongue and groove running east-west, and painted in various hues of green, with a strip of yellow near the north wall. Two circular holes were been cut into the ceiling.

A 10-1/4" diameter hole toward the east end of the room was most likely part of a heating system and shows considerable heat blistering to the paint in its vicinity. There is also a filled-in hole for a light fixture close to the center of the room, as well as a recessed light fixture and a recessed electrical junction box (to the north of the stove pipe hole). Another recessed light has been cut into the ceiling near to south wall, above the area that until recently included a modern sink arrangement.

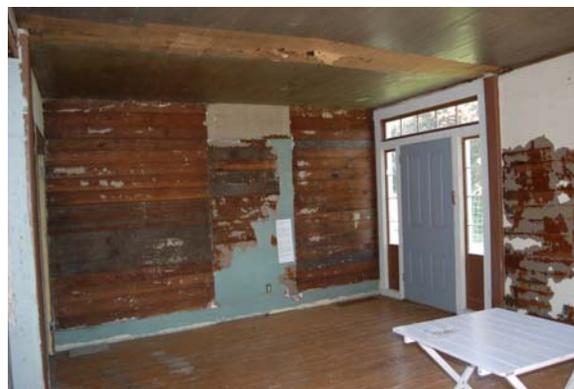
The SE Room (104) served as the foyer and parlor. The room is 19'1" north-south and 13'10" east-west. The ceiling is 8'10" from the floor, clad with 3/4"x3-1/2" tongue and groove running north-south, and painted green. A strong seam cuts across the ceiling 6'8" from the north wall marking the line between the two-story and one-story sections of the house. All signs indicate there was once a wall here dividing the foyer from the parlor. There are square nail holes in the floor and ceiling along this seam and there are projecting boxed-in elements at each wall where the missing wall would attach. If the casing was removed from the projecting boxed elements, most likely a mortise for a diagonal wall brace would be seen.

The sheathing on the walls is 5-1/2" to 6" tongue-and-groove boards. These were covered in a cardboard-like cladding (1/16" thick gray paper) and then wallpapered with 20" wide rolled wallpaper. Some of the cardboard and wallpaper has been removed, though the south and west walls are still mostly covered with heavily damaged paper. Most likely these walls were originally covered in muslin and wallpapered.

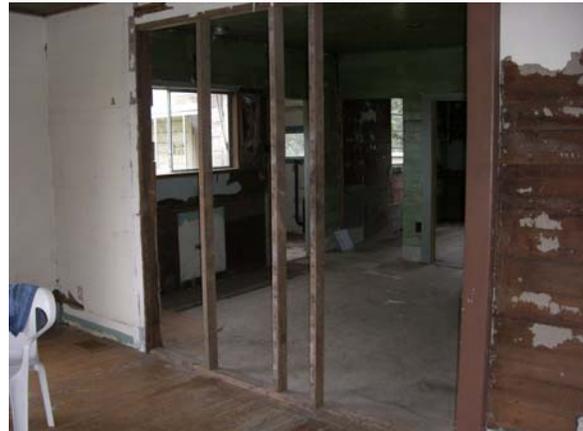
The west wall is a combination of open studs and sheathed wall. The south end of this wall is still sheathed and has a full-dimension 2"x4" stud within it. The remaining studs in the non-sheathed portion of the wall are 1-1/2"x3-1/2" studs indicating a later construction date. Traveling farther north along this wall, there is a 3'0" wide passage into the Kitchen, then a solid wall enclosing the backside of the stair landing, and then finally a door opening leading into the Center North Room. This door opening is

surrounded by a simple 5-1/4" plain casing rather than the formal pedimented casing of the windows. If the foyer wall had not been removed, this door would have been at the rear of the foyer. What is intriguing is that the backside of this door opening has the formal pedimented mouldings of the Center North Room.

The other pressing decision for this room is what to do about the open west wall. There is evidence from the partially sheathed wall that the wall continued farther north. The biggest question is whether there was an opening into the Kitchen. At the north end of the wall, a knee brace has been removed. Most likely there was not an opening there originally. The modern, open stud wall is concealing the answer. Careful invasive exploration around where this wall would connect should give the answer whether there was a wall here, if there was a door opening through the wall, and if there was opening where it was and how wide it was. Most likely this was a solid wall. Mary Jo Morelli has been researching Connecticut housing of the period, and often there was only one door into the most formal room from the foyer, which lends credence to the idea that the west wall had no openings originally. Making this wall solid and returning the knee brace would add to the stability of the house's structure. As with the foyer wall, restoring the wall here will change the parlor space drastically.

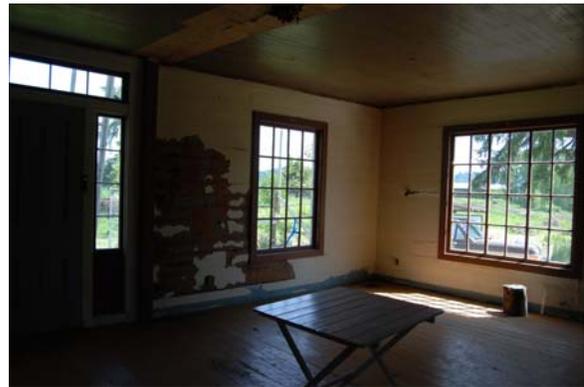
Another pressing decision to be made for this room is the replacement of the 24-pane window in the south elevation and the 16-pane window in the east elevation. The two windows are not original to the house and based on photographic evidence, were inserted sometime after 1934. Since photo evidence exists that these windows were "identical" to the windows on the north side of the front door, we would recommend eventual reconstruction of the windows.

Careful removal of some of the interior and/or exterior cladding will reveal the original framing locations for these windows. However, there is no pressing urgency to restore these windows, as the current windows are serving their purpose adequately.

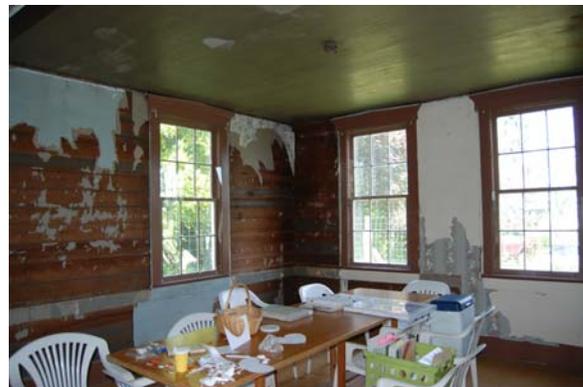
The NE Room (105) was used as a religious meeting room. The room is 13'4" north-south and 13'10" east-west forming almost a perfect square. The ceiling is 8'10" from the floor, clad with 3/4"x3-1/2" tongue and groove running north-south, and painted green. It is one of the more elaborate rooms in the house with an open wall to the west that could be close off with a pair of large bi-fold doors. The doors themselves are detailed in Appendix E.

The sheathing on the walls is simple 3/4"x5-3/4" horizontal boards. These were covered in a cardboard-like cladding (1/16" thick gray paper) and then wallpapered. Most of the cardboard and wallpaper has been removed; however, there is a large remnant of the floral wallpaper on the north wall. Most likely these walls were originally covered in muslin and wallpapered.

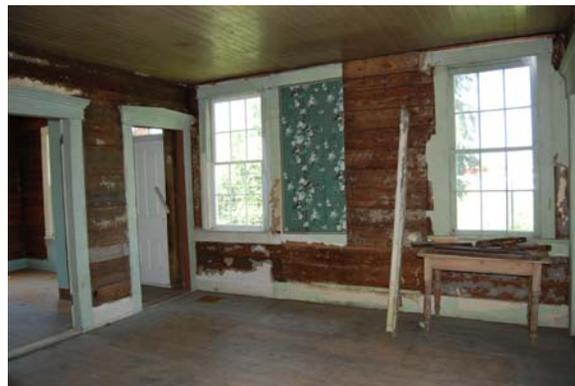
The Center North Room (106) was a multipurpose room and the only room with a fireplace. The room is 16'6" north-south, 13'9" east-west, and 8'10" tall. The ceiling is clad with 1"x3-1/4" tongue and groove running north-south, and painted beige.

The sheathing on the walls is simple 3/4"x5-3/4" horizontal boards. These were covered in a cardboard-like cladding (1/16" thick gray paper) and then wallpapered. Almost all of the cardboard and wallpaper has been removed; however, there is a large panel of wallpaper with birds on the north wall behind the fireplace. Most likely all these walls were originally covered in muslin and wallpapered.

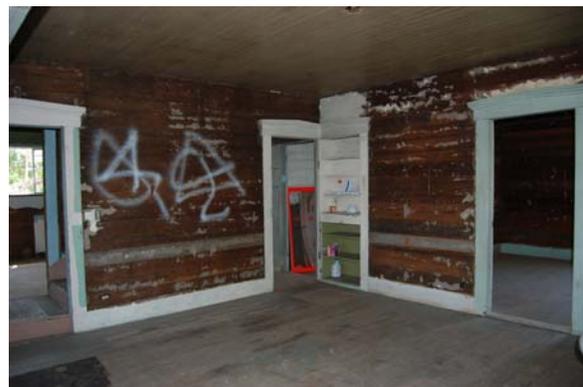
At the south end of the west wall is a set of shelves set into what looks like the standard door opening. These shelves are divided into two cabinets, the top cabinet has four shelves and the bottom cabinet had three shelves. Each cabinet was covered by a pair of double doors, now removed. The cabinetry is deep enough that it extends into the Pantry Room behind. It appears this pair of cabinets is original to the house and not just an infilled doorway. The cabinet doors were not inspected so they may tell the tale once examined.

There is an electrical outlet located between the windows in the north wall, one in the south wall, and one in the west wall. There was one ceiling light fixture with box centered in the room. There is a switch for the light on the south wall. We assume this switch also operated the ceiling fixture in the NE Room. There is a metal floor register 10"x12" with faux graining in the northwest corner of the room. There is a plywood cover over the 2'x2' hole in the southwest corner for the principal air return for the furnace below. Its vent grate was stolen precipitating the removal of the doors and hardware for protection against theft. There is a piece of thin plywood covering a large hole in the floor near the southeast corner of the room.

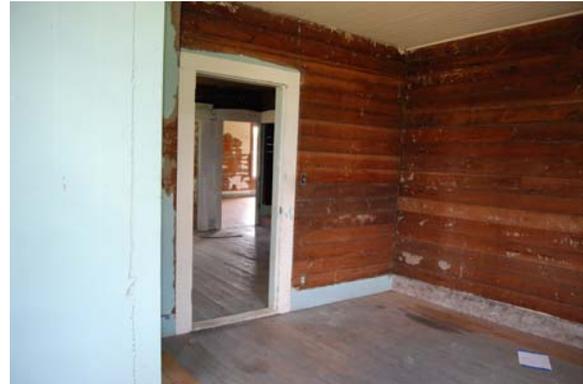
The original function of the Northwest Room (105) is unknown, though in later years it served as a bedroom. The room has an L-shape, with a vestibule taking up what would otherwise be its northeast corner. The room's maximum dimensions are 14' north-south, 12'2" east-west, and 8'10" tall. The vestibule extends 3'5-1/2" from the north wall and 4' from the east wall.

The ceiling is clad with painted, beige 1"x3-1/4" tongue and groove running east-west. The boards are continuously interrupted in the area near the vestibule. This patch is located approximately 5'4" from the north wall and 5'10" from the east wall. The patch is perplexing because its vicinity to the vestibule suggests that the two are somehow associated, yet, it is considerably larger. The tongue and groove boards in the patched area are also identical to those of the main ceiling area, implying that this was not some hasty later installation. The patch also lines up with the framing of the east door leading into the Center North Room. It is possible that the vestibule was originally larger, but was reduced in size, resulting in a larger Northwest Room. The current dimensions of the vestibule also seem unplanned because its walls run into the trim of the exterior door on the north wall as well as into the trim of an opening toward the Center North Room.

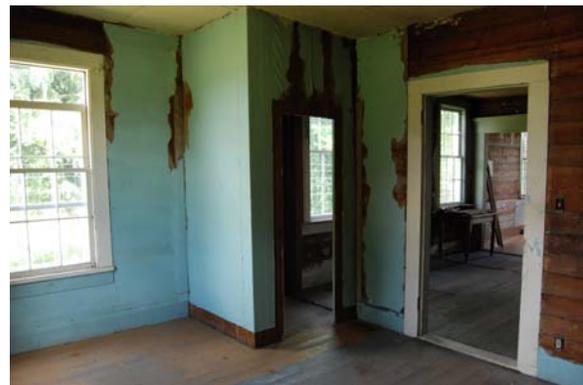
The vestibule consists of a single wall of 6" to 8-1/4" wide tongue and groove boards installed vertically. A 2' wide by 6'3" tall passage was crudely cut into its south wall, creating an opening into the Northwest Room. This opening dates to the Zurcher period of the house, when the vestibule was closed off and turned into a closet for the Northwest Room. The inside of the closet/vestibule was covered with at least three different layers of wallpaper. The remaining paper shows signs of water damage, particularly on the ceiling toward the east. The door to the exterior on the north side, is original and features four panels with the bottom two shorter than those on the top. The three-pane transom above the door is a reconstruction of the original. The closet's wooden door and its trim (which was attached with square cut nails) was recently removed and is stored in the Pantry (Room 108). The vestibule walls were covered in the cardboard-like cladding and multiple layers of modern wallpaper, like many of the house's other rooms. Because of this, it initially appears that the entire vestibule/closet is a fairly recent construction. However, some evidence suggests otherwise. The ends of the tongue and groove boards are nailed to the floor with square nails. The cardboard-like cladding stops abruptly about

5-1/2" from the floor, the height of the baseboard that runs around the perimeter of the room. The floor's paint stops 1" from the vestibule, roughly the thickness of the baseboard or of quarter-round trim.

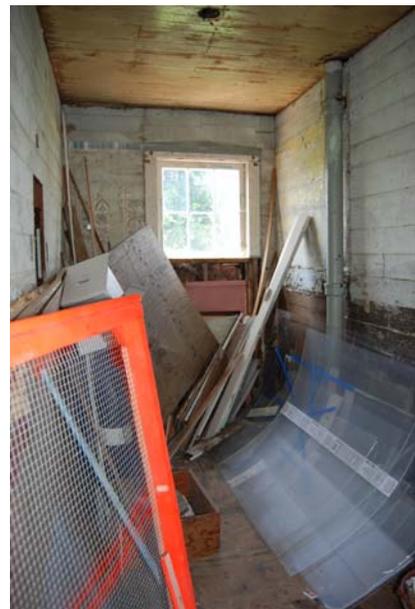
There is one door and one window in the room. The east wall contains a door next to the built-in cabinet. The door opening is trimmed in simple casing without a pediment. The window is trimmed out with the typical pediment, however, the pediment cap has been removed. The lower sash opening has also been removed and crudely filled in with modern dimensional lumber and pink insulation. The infill is as obvious on the exterior as it is on the interior.

The original flooring is tongue and groove and is covered in spots in worn linoleum. Much of the remaining floor is plywood as the floor was heavily damaged by moisture from the tub. The room is difficult to assess because it is currently loaded with large acrylic sheets and various building materials.

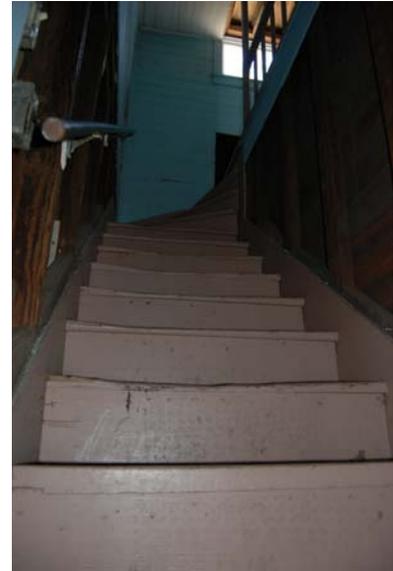
The stair up to the first floor is unusual, to say the least. Its landing at the first floor is reached by one step up on either the north (from the Kitchen) or south (the Center North Room) sides. Likely, the opening from the Kitchen to the stair did not exist originally, as its casing treatment is crude. From the landing, there are 14 steps to the second floor, the last three winding to the north creating the dog-leg stair. The heavily worn treads are 11-1/4" x 1-1/4" and slightly bull-nosed. The rise varies from 8-1/4" to 8-1/2". The north wall enclosing the stair has had its sheetrock removed revealing full-dimension 2"x4" laid flat. The south wall has also had its sheetrock removed revealing full-dimension 2"x4" laid normally, 19" on center.

A decision will have to be made whether to sheath the walls or not. The studs should be examined for nail holes to see if board sheathing was originally applied here. A period-appropriate handrail should be installed. Other houses of the period could be examined to see what would be appropriate. Some of the stair treads are so worn that they bounce easily. Several of the weaker treads should be examined and possibly replaced. The old treads should be saved and stored in the attic. The two light switches on the south wall should be removed.

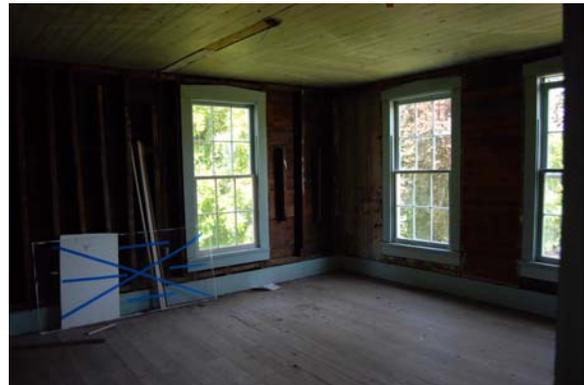
The Northeast Room (202) served as a bedroom. According to an interpretive note, this room once included applied ceiling tiles and a built-in closet, both since removed. The room measures 13'3" north-south by 14' east-west. The ceiling is 7'10" from the floor, and is finished with boards in two widths. From the west wall there is 4'7" of 3-1/3" wide boards. The remaining ceiling is covered with 5-1/2" boards. There is no physical evidence to explain this variance. Like the northwest room, the northeast room's floorboards run from north to south and consist of 16' long, 6-1/4" wide and 1-1/8" thick tongue and groove. There is a patch in the floor near the west wall, approximately four feet from the south wall. This may have been the location of a heat register.

The door to the hall is located toward the west end of the south wall. The opening retains its simple pedimented casing. The south wall was totally stripped of sheathing, probably at the point in time when drywall was installed. The wall studs and scabbed-in nailers are fully exposed. The nailers, full 2" x 4" lumber, are clearly scraps, and vary greatly in length and condition. When the sheathing was removed, the 8" wide mopboard was left intact.

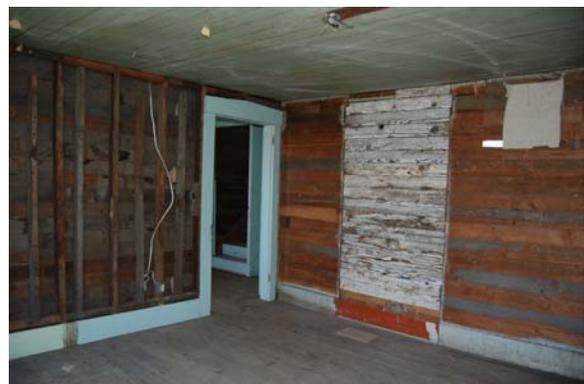
On the west wall there is a boarded-over door opening that led to the unfinished northwest room. The opening is filled with 4-

3/4" tongue-and-groove scraps that were painted white, most likely prior to their installation. It is not known at what time the opening was closed. Paint shadows and notched-out sheathing boards indicate that the opening was finished at one point in time. The west wall also includes a hole for a stovepipe, located 4' from the north wall and 6'-4" above the floor. Its diameter is 10-1/2". The hole is significant because its gasket protected the original wallpaper beneath it. As a result there is a small fragment of paper that never was exposed to light and therefore retains its full color saturation. The pristine fragment is protected from solar exposure by a cloth attached to the ceiling.

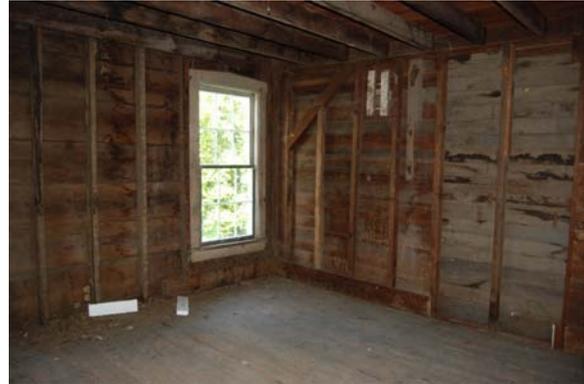
The northwest room measures 13'9" north-south by 13' east-west. The unfinished ceiling is 7'11" from the floor. The door to the hall is located toward the east end of the south wall. There appears to be a blocked off door opening on the room's other interior wall (east), slightly to the south of center. The north wall includes two windows, while the west wall is without openings. The room's walls, as well as the ceiling are unfinished. According to interviews with Pete Zurcher, long-time resident of the house, this room was always unfinished. The absence of any fragments of finishing materials seems to confirm this. The room's unfinished state and blocked door to the adjoining room raise questions about its use. Was it originally intended to serve as the room for a child, with easy access from the parental room (Northeast Room #202)? If so, it may never have been completed because no children resulted from either of A.T. Smith's marriages. Was the upstairs floor designed to be used as an independent living suite, with one room serving as the bedroom and the other as a study or parlor? To date, no written material has been uncovered that might clarify the room's use.

The northwest room's flooring consists of 6-1/4" wide and 1-1/8" thick tongue-and-groove boards that run from north to south. Alternating boards are interrupted at about 20" from the exterior wall to avoid a continuous joint at the ends of the boards. The boards are 16' long and run under the interior south wall and into the hallway. At the north wall, roughly at its center, there is a patched section with non-matching floorboards. The patch is 2'6-3/4" wide and approximately 1'8-3/4" deep. The floorboards in this area are only 3-1/4" wide. Apparently an interior chimney stood in this area.

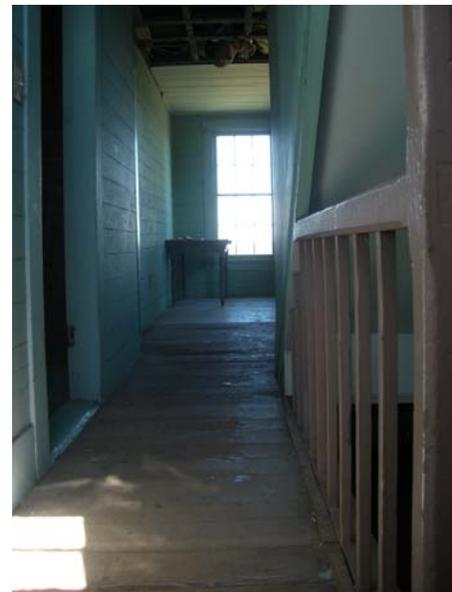
The balustrade, including a top rail and plain, straight balusters, along the stairwell on this floor is wooden, painted, and in stable condition. There is a chamfered post measuring 2"x2-1/2" (and 6'3" at the highest slant of the top) at the head of the stairs. The chamfered top rail measures 2-3/4" x 2-1/8" x 4'10" (at the farthest slanted edge under the stairs to the attic). The balusters are 1" x 1" x 2'3-1/8" and are spaced, from west to east, as follows: 7-3/4", 6-3/4", 7-1/8", 7-1/8", 7-1/8", 7-1/4", 7-1/4", 7-1/4", 7", and 10-1/2".

Walls of the second floor hallway are of blue painted, horizontal boards. They vary in height along the room side (4-3/4" to 5") whereas the heights on the south side are only

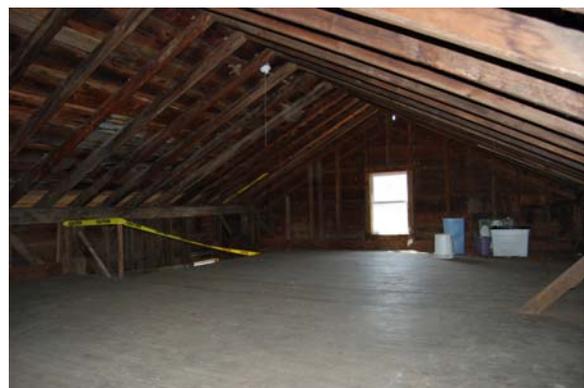
The oak corner posts are roughly 8"x8" and have a corner square channel chiseled out

(the corner of each post pointing to the interior). The middle posts are roughly 11"x11" and have a chiseled "T" profile. Walls studs fill in between the massive timber-frame supports. Studs run continuously down to the second floor. The framing is generally visible and stable.
