# Frantz-Dunn House

## Condition Assessment Report 1997

By: David Pinyerd, Historic Preservationist

For: Benton County Parks

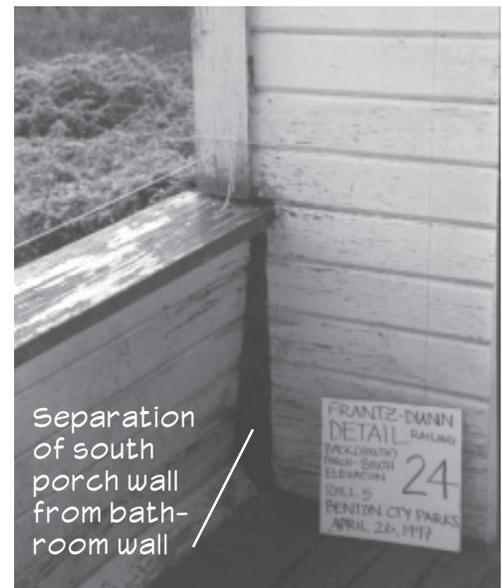
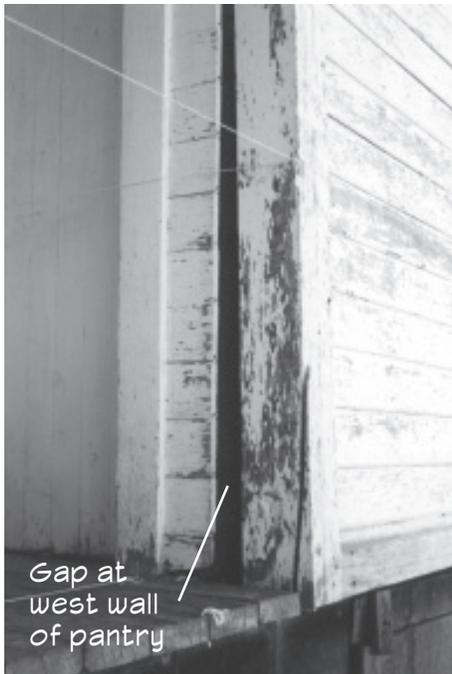
The wall structure appears quite stout and sound. The building is moving with the foundation settlement and will probably move back into a level configuration when the new foundation is inserted. The only location I'm concerned about is the half wall along the south porch. This area is buckling for reasons that need further examination through the removal of some of the siding pieces on the half wall. I believe the wall is rotting at its base and is beginning to collapse. The rotting condition would be caused by water trapped behind the wall since the porch is sloped to the half wall and the drainage points have been closed.

Another cause may be the weight of the boxed in porch posts carrying the south roof. Quite possibly the posts do not go all the way through to the foundation and are merely setting upon the half wall. The east-west beam holding up the porch roof maybe transferring some of its load to the boxed posts which in turn are pushing down on the half wall causing it to collapse under a load it was not intended to carry. Either way, by rot or weight, the cause can be discovered with the removal of a few pieces of shiplap.

**Solution:** The half wall must have some of its siding removed and examined further. It maybe repaired with modern materials; however, it should be resheathed in the original shiplap. The ogival drainage ports should be reestablished; the port on the east side should be used as reference.

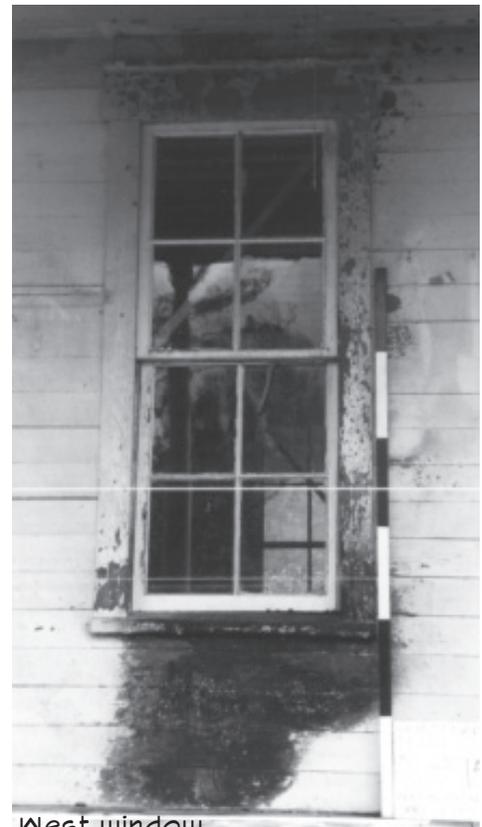
West window

The windows exposed to weather (not those covered by porches) are in desperate need of reglazing. I have marked with an "X" on the elevation drawings those window panes that need reglazing. I have marked with an "✱" those panes that need replacing due to significant cracking or holes.

keep the original craftsmanship. Two products I would recommend are Abatron Liquid Wood for consolidation and Abatron Epoxy Filler for replacement of missing wood. I recommend a cautious use of epoxy and to never use it on a structural member, such as a porch post base. In most cases I would recommend replacement with in-kind materials; however, on window sills I have seen epoxy used to great effect. Also, while the sashes are out, the window surround should be inspected and paint removed from the operating track.

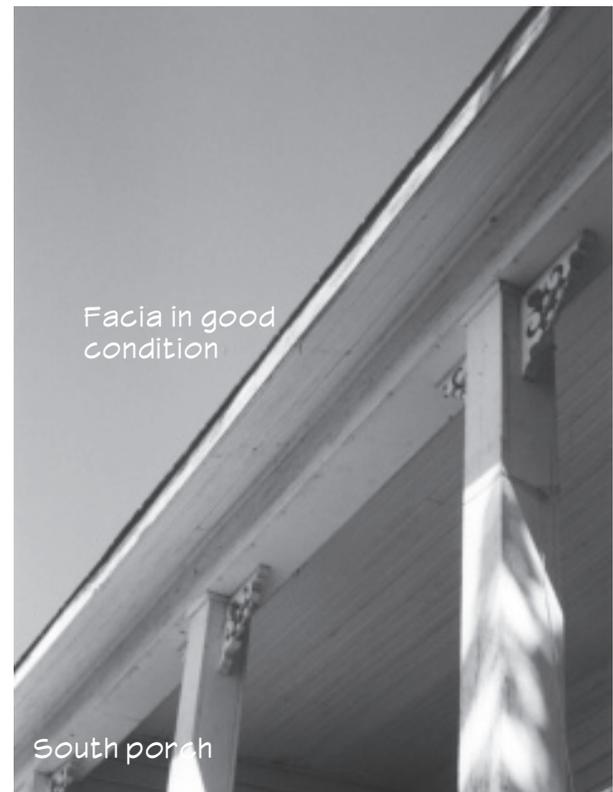
Also, on the west elevation on the south side of the east-west wing (see figure on next page) the crown moulding and fascia have come loose allowing water to penetrate the soffit area.

On the west elevation on the south side of the east-west wing where the crown moulding and fascia have pulled loose, the rafter tails should be examined for deterioration by the contractor, any rotted portions replaced, and the fascia and moulding reattached with stainless steel nails. There is a similar situation on the NE corner of the house and it too should be inspected and repaired.

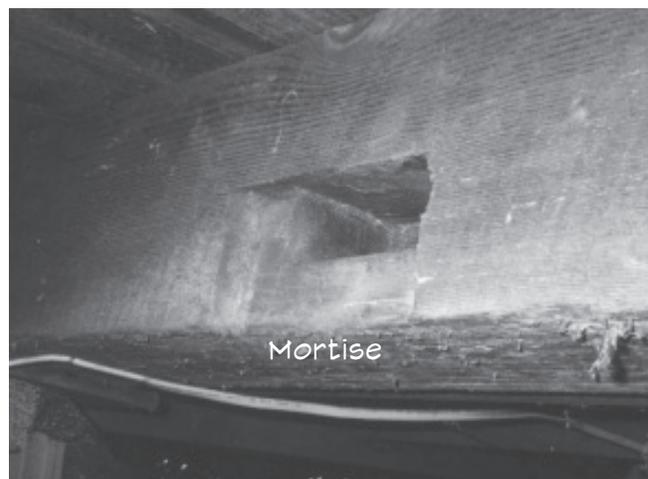
As for the reuse of Fort Hoskins in the construction of the Frantz-Dunn House, I could find only one telltale sign of the Fort. In one of the 8"x8" carrier beams running east-west under the house, I found an unused mortise that

is too complex to have been used in the construction of the house. The beam must have been recycled, but from where I cannot be sure.
